# WILMINGTON INSPECTION GROUP

Name: John Sample  
Address: \_\_\_\_\_  
\_\_\_\_\_  
E-Mail: [john@inspectilm.com](mailto:john@inspectilm.com)  
Inspection Ordered by: Client  
Property Address: 123 Wilmington Lane  
Age: 2015  
Square Footage: 1234+  
Date Performed: 1234+  
Reason for the Inspection: Prepurchase

## I. Foundation, Basement and Structure

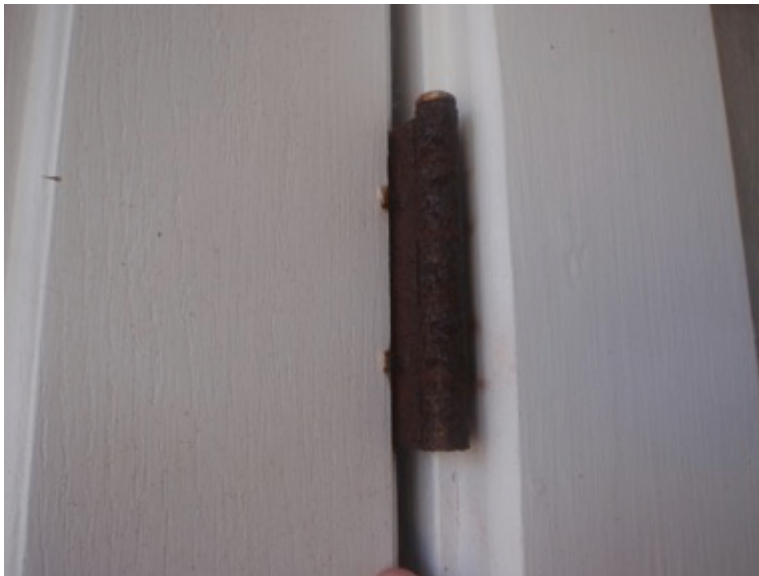
Majority of exterior door hinges on subject home doors need replacement due to salt air corrosion and heavy usage

6. **Almost all exit doors of subject home were observed with rusted out door hinges and need to be updated by a qualified contractor.**
7. **Exterior doors (sound side porch doors and front entry doors) are showing signs of age with moisture exposure/delamination at bottom door slats and 2<sup>nd</sup> floor sound side door needs adjustment and weather stripping improvements are recommended on all doors of subject home.**

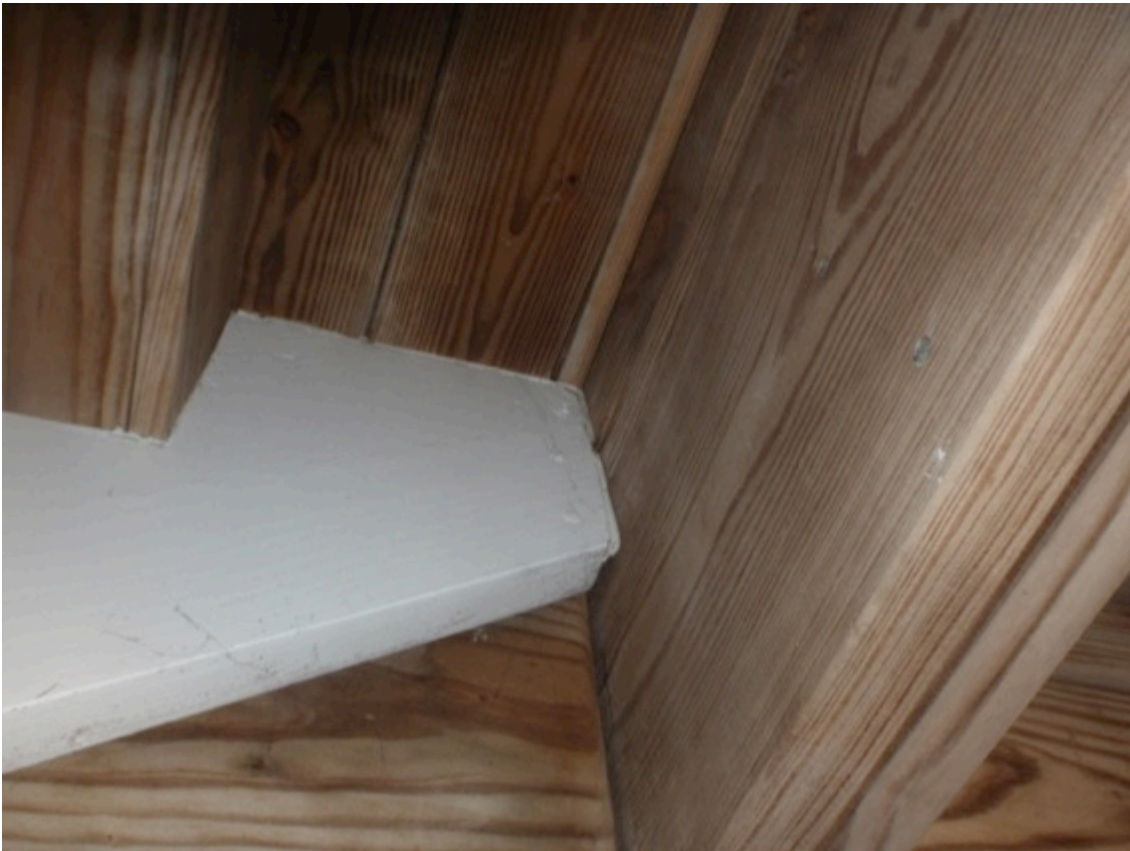
Exterior stair stringer support boards that tie into band joist at deck platform framing need ledger strip or joist hanger supports added to properly support stairs runs on home \*Old code compliant

15. **Front door handle is loose and needs securing repair.**
16. **Recommend adding ledger strip or joist hanger support to all exterior stair stringer connections to landing band joists of subject home. Nailed only right now.**

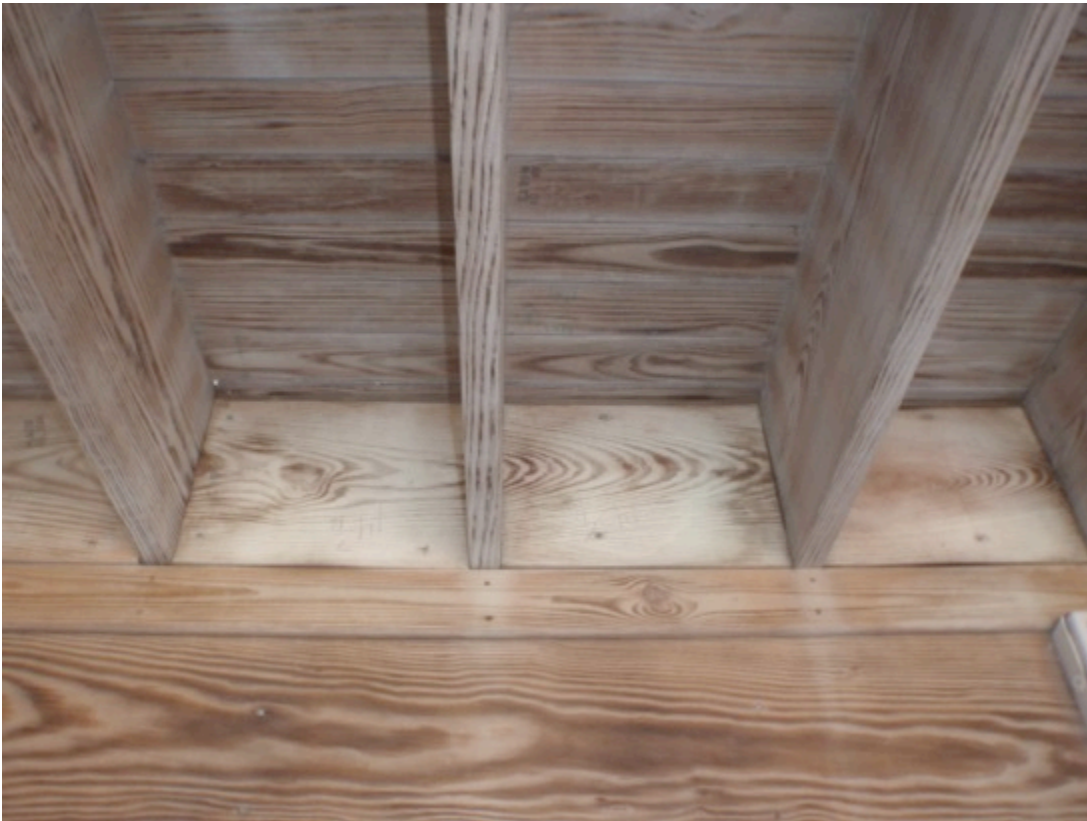
- \*Client should anticipate corrosion repair of nails and fasteners to deck supports moving forward due to salt air corrosion exposure, repair as needed moving forward
- \*All decks today must have band joists lag bolted to structure, lag bolt connections were not required when homes was permitted, client may want to consider adding moving forward, nails used when homes was built tend to break down over time due to corrosion from salt air exposure

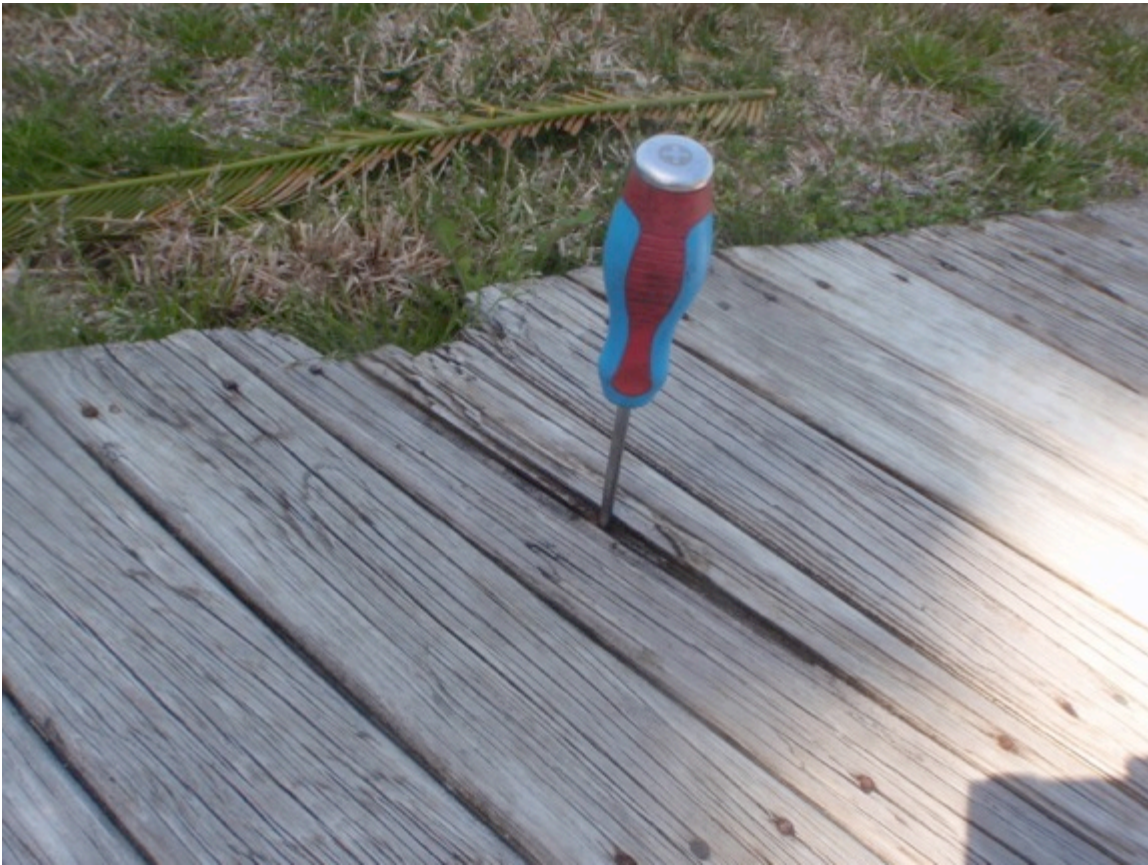
Plank walk boards at back patio are in need of repair \*multiple

- 2. A qualified contractor needs to evaluate back patio area 1<sup>st</sup> floor walk board planks on sound side of home. Corroded fasteners from salt air and individual board replacement of multiple water damaged boards should be anticipated.**

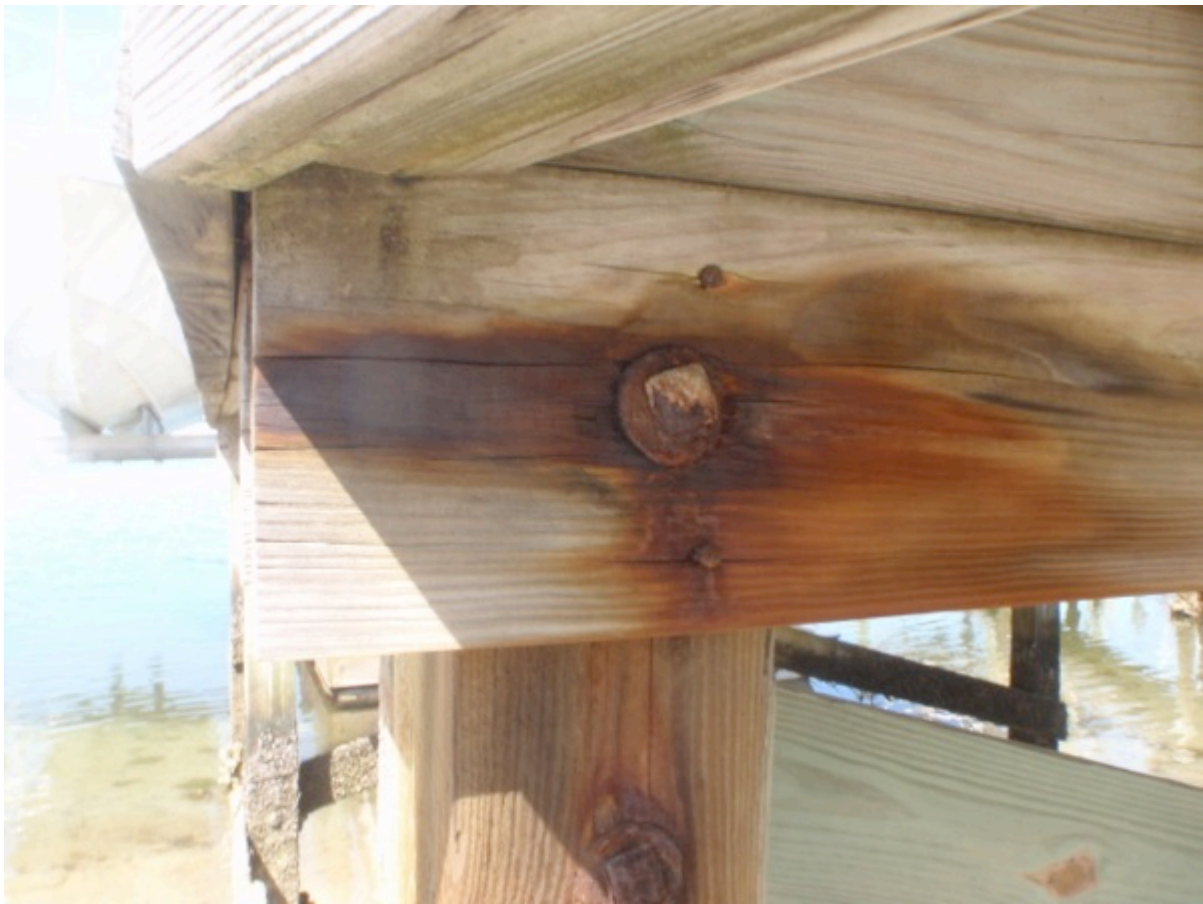
Full evaluation of dock, bulkhead, and boat slip/lift conditions is recommended by a qualified marine contractor, view of above is of corroded deck support fastener under deck walk boards leading to gazebo

- 1. Dock and dock walkway of subject home is in need of repair by a qualified contractor. Railing height and picket spacing is not to current code and need repair. Numerous dock walk boards need repair and 2<sup>nd</sup> floor deck supports all need joist hanger supports added. Deck ramp that leads to lower dock where boats are located also needs to be evaluated and repaired for safety. Under dock walkway support bolts are rusted out and appear to need replacement due to long term exposure to salt air. It is recommended a qualified licensed marine contractor evaluate and advise client on repairs to make safe. Pilings, fasteners, bulk head, dock, and boat lift need to be evaluated in third party marine contractor inspection.**

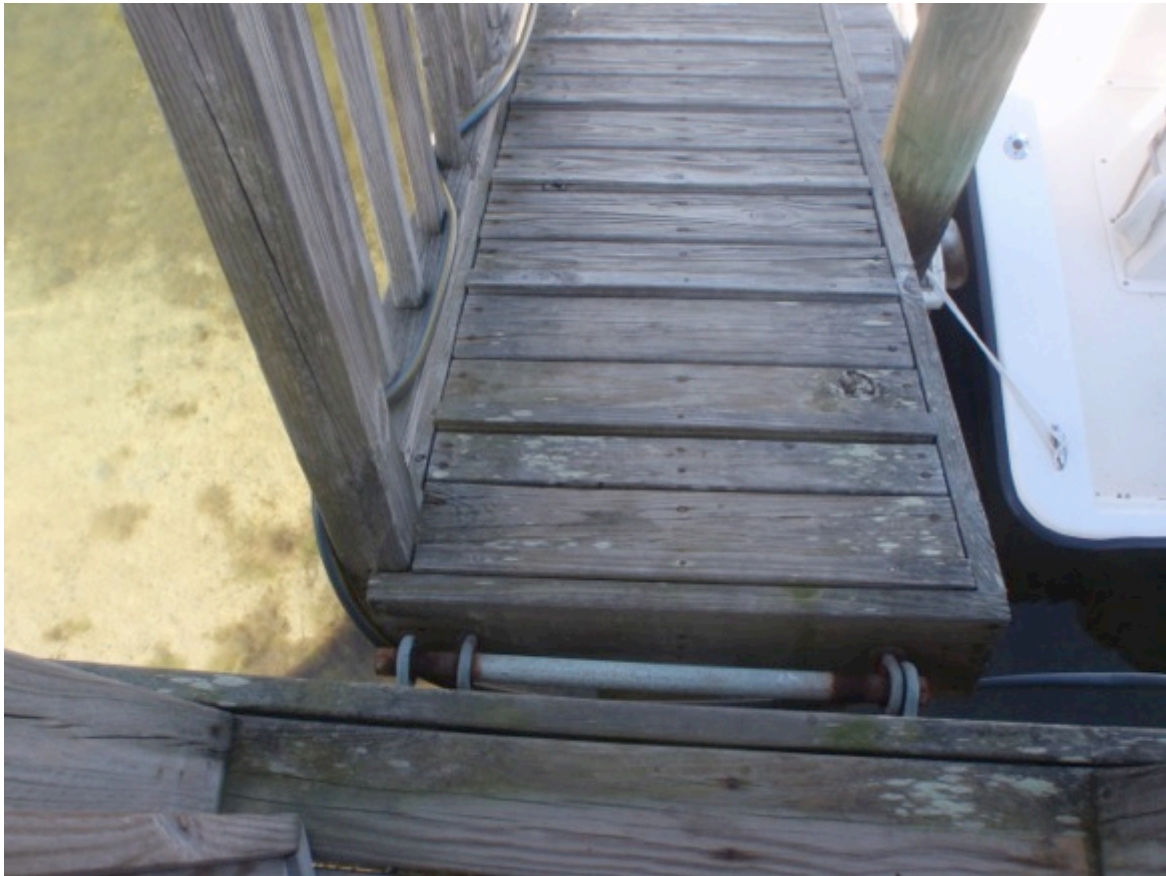
Gazebo to floating dock transition needs securing repairs by contractor

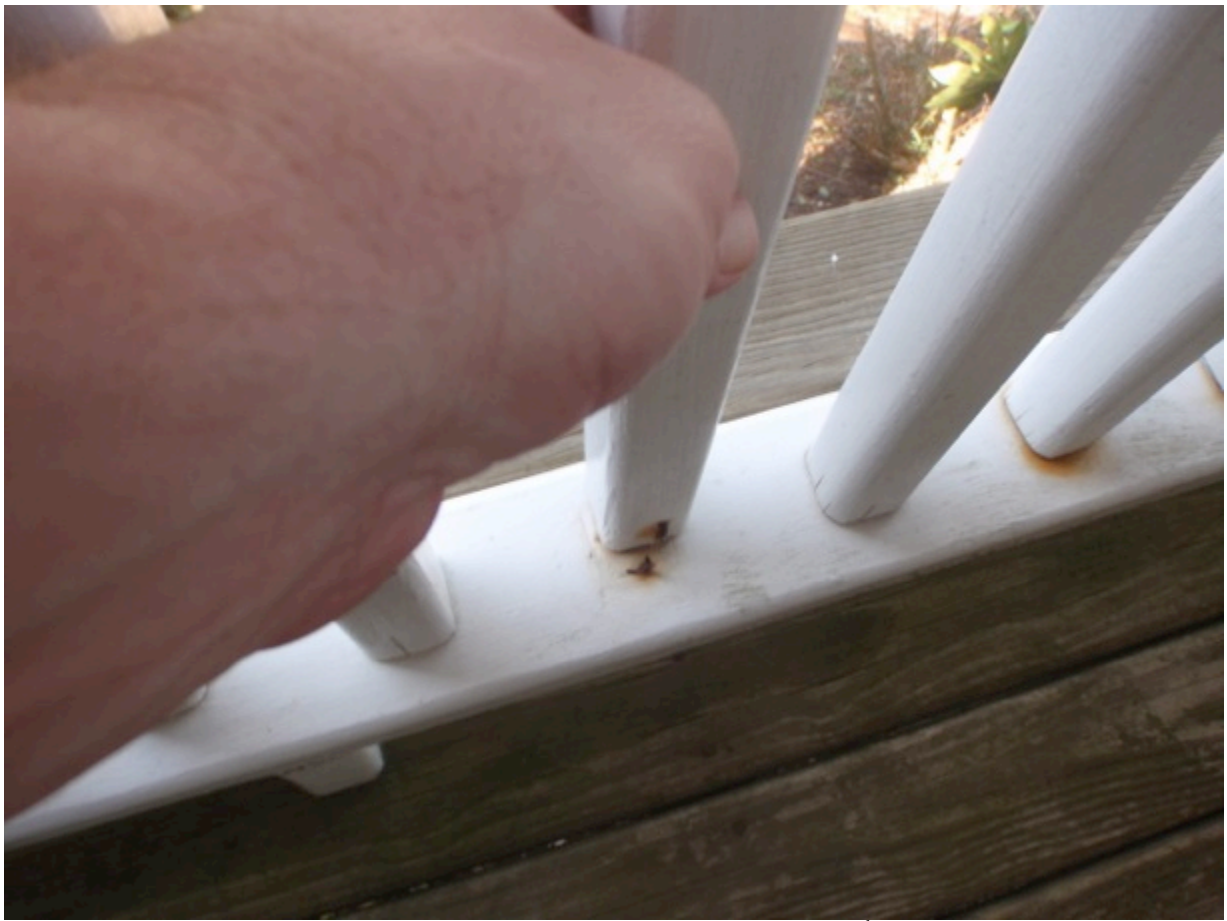
View of rusted out fastener nails and loose railing pickets observed on 2<sup>nd</sup> floor main house deck railing

10. **2<sup>nd</sup> floor sound side railings need attention. Multiple loose railing pickets are corroded nails from salt air exposure observed, recommend contractor evaluate, identify and repair.**

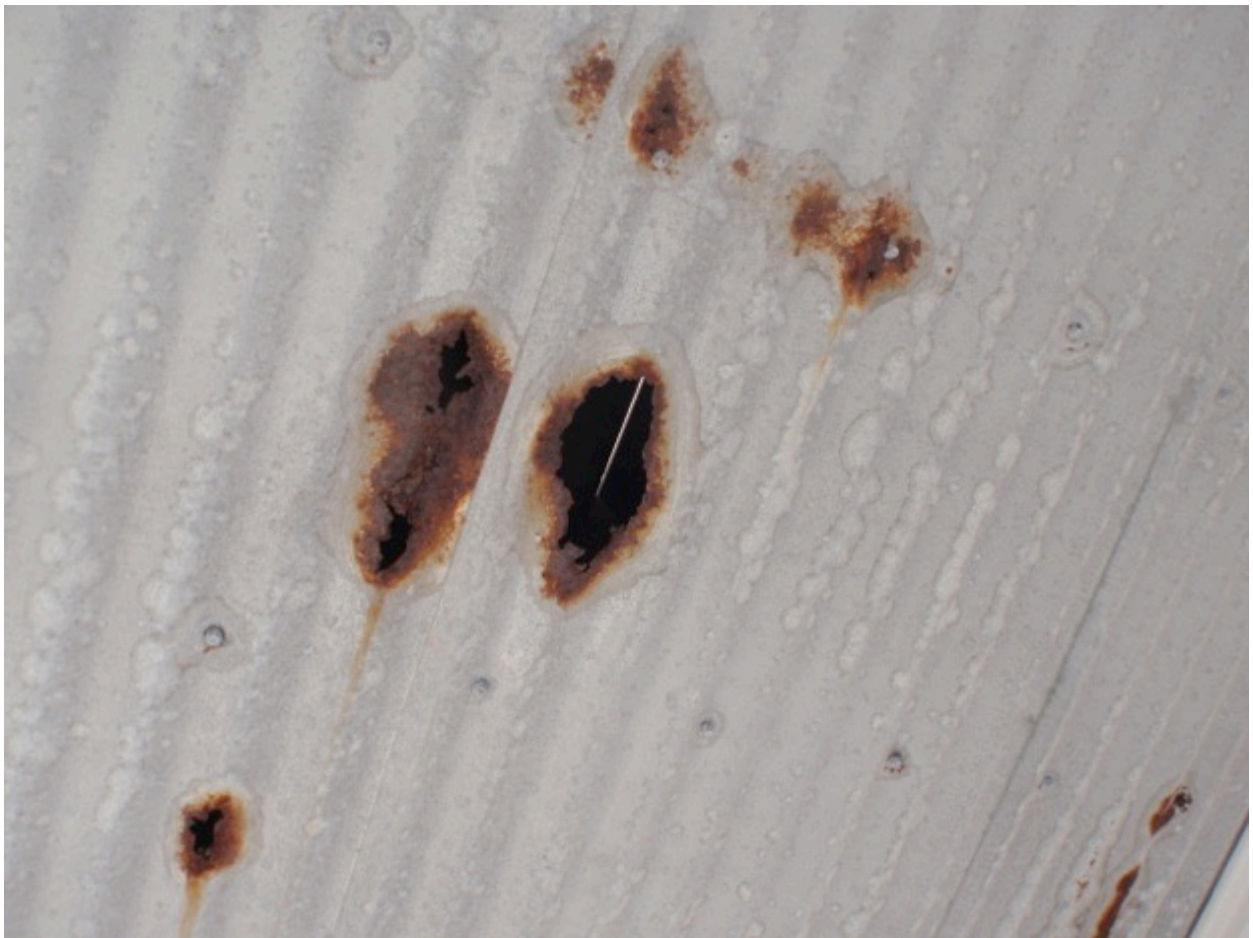
All deck overhang rain water diverters need to be replaced on all deck underpinning on sound side of home

12. **All sound side decks (all levels) need a qualified contractor to replace underlayment-corrugated weather shields that catch rain water thru decks need to be replaced. Corrosion and holes observed, recommend a qualified contractor advise.**

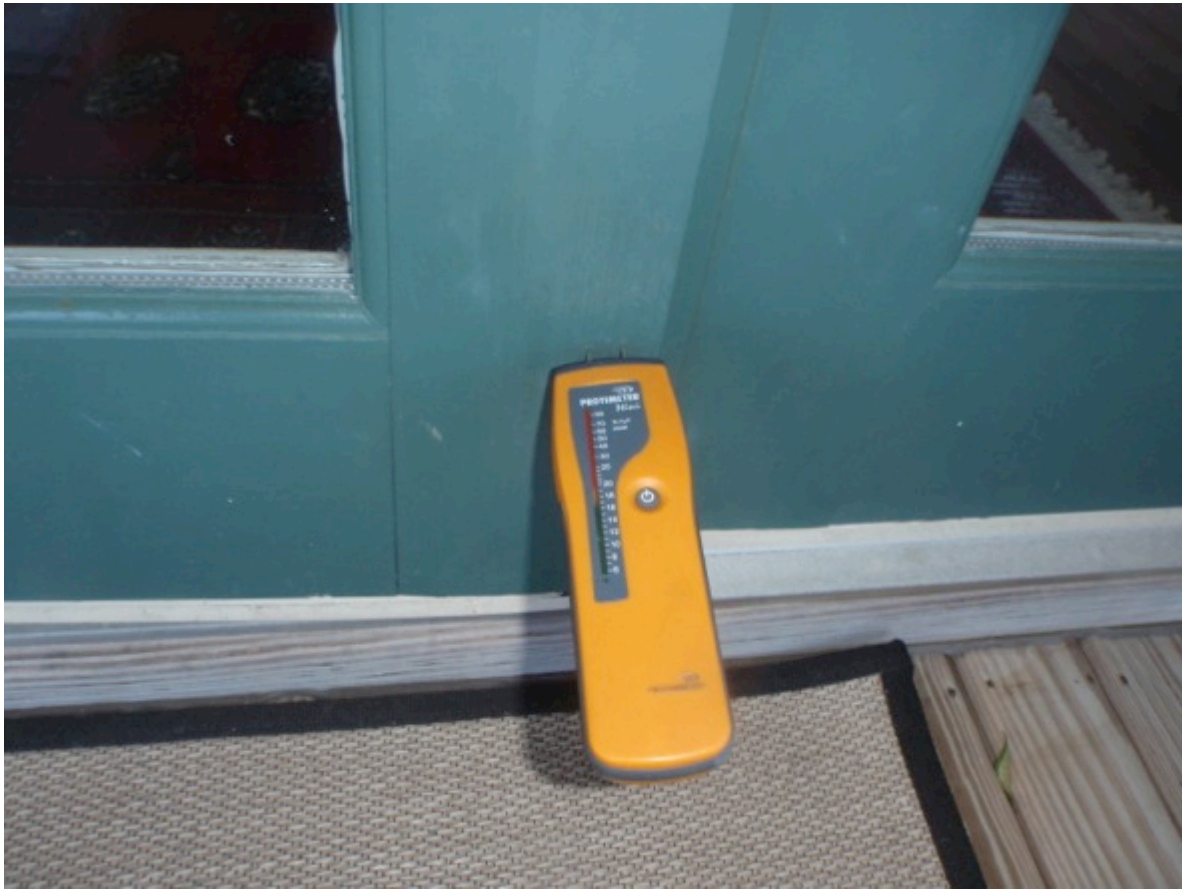
Multiple exterior doors are showing signs of moisture exposure to door slats and need hinge and weather stripping adjustments

5. **Moisture exposure/damage was observed at bottom of first floor entry door into property, 3<sup>rd</sup>/4<sup>th</sup> floor sound side deck exit doors and hinge adjustment weather stripping exit door repair is needed on 2<sup>nd</sup> floor sound side door. Recommend a qualified contractor repair.**

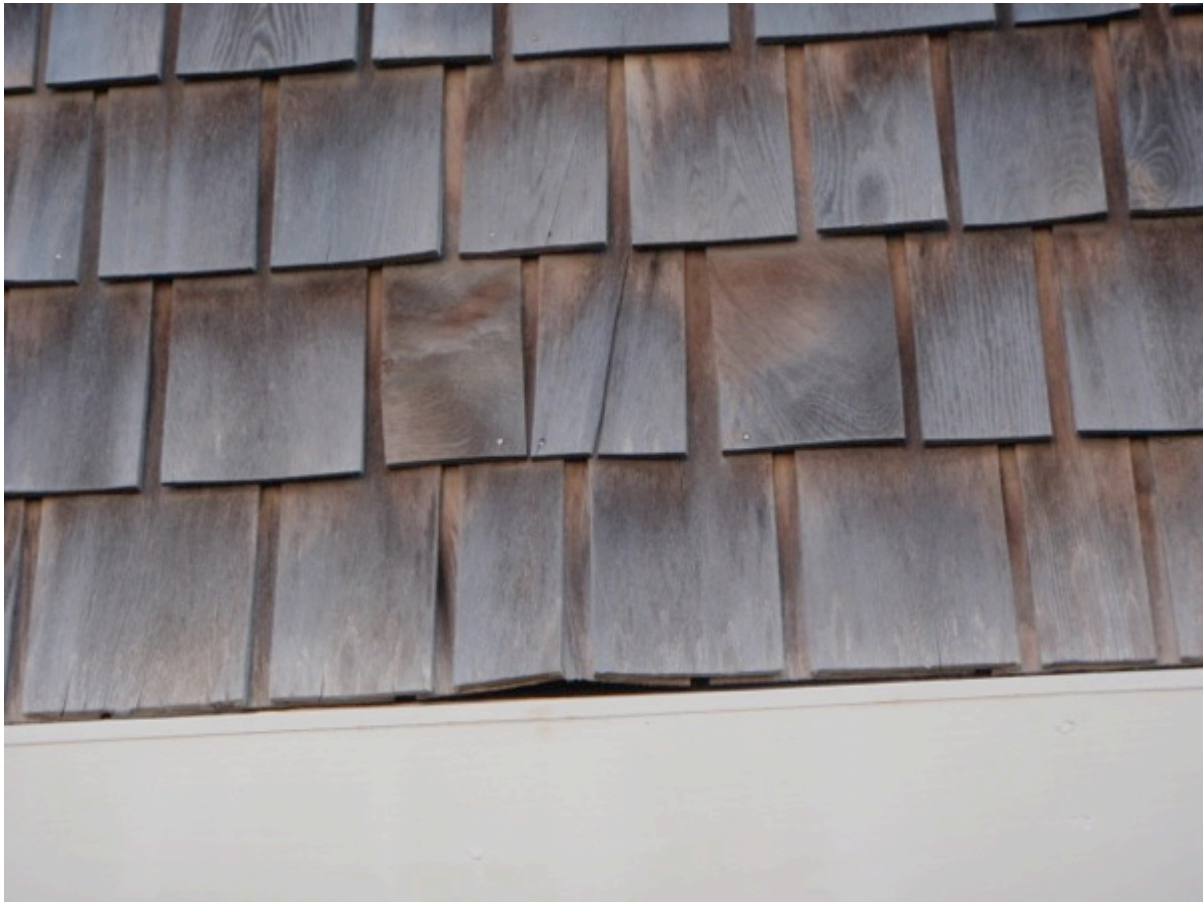
View of original cedar siding observed on exterior cladding of subject home, note numerous past nail securing repairs have had to be added to secure loose shingles over the years

14. **Exterior cedar shake siding on exterior cladding of subject home is original. Southern exposure siding shakes at front view of home are showing signs of age/exposure to weather and majority of siding shakes at right hand side yard of home have had past securing repairs performed by contractor in the past. (thru nails) Multiple wind blown shingle movements have occurred on individual siding shakes on all four sides of home. Shingles original paint/sealing has deteriorated due to age also. Caulk lines around windows also need re caulking at all exterior window and door locations. It is recommended that a qualified siding professional evaluate further and advise client on repairs/improvements of exterior cedar siding shakes.**

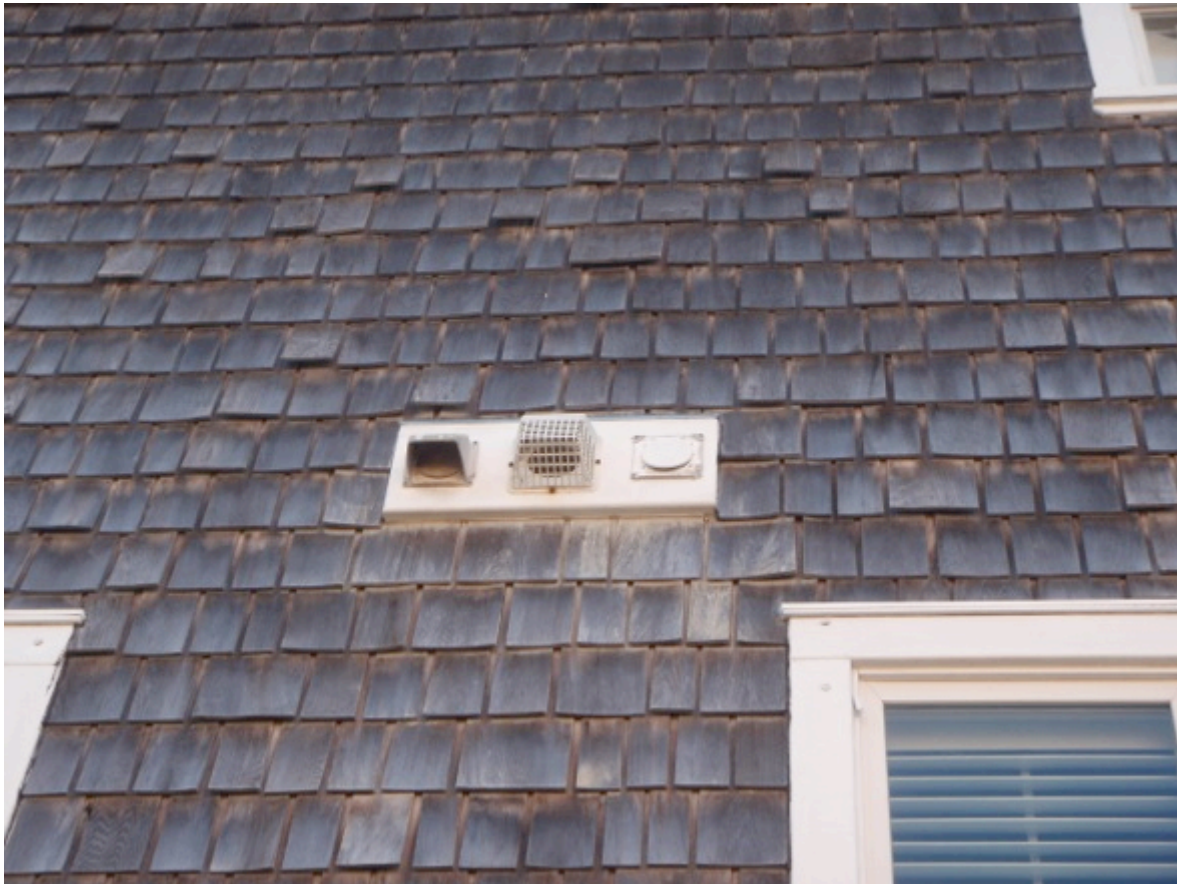
View of missing side yard bathroom vent fan cap, also note window shifted shingles and weathering of original tabs

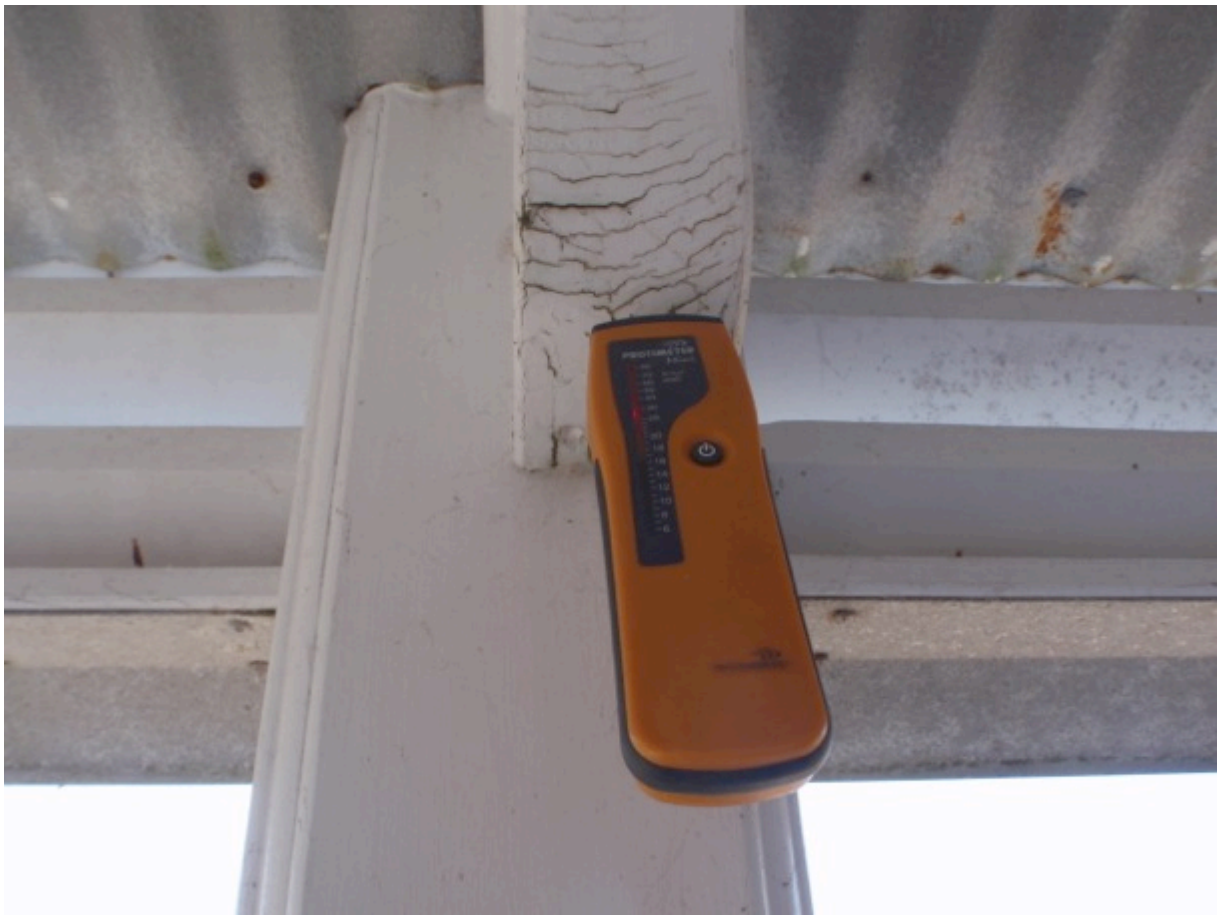
View of moisture exposure/damage at sound side porch 3<sup>rd</sup> floor framing detail

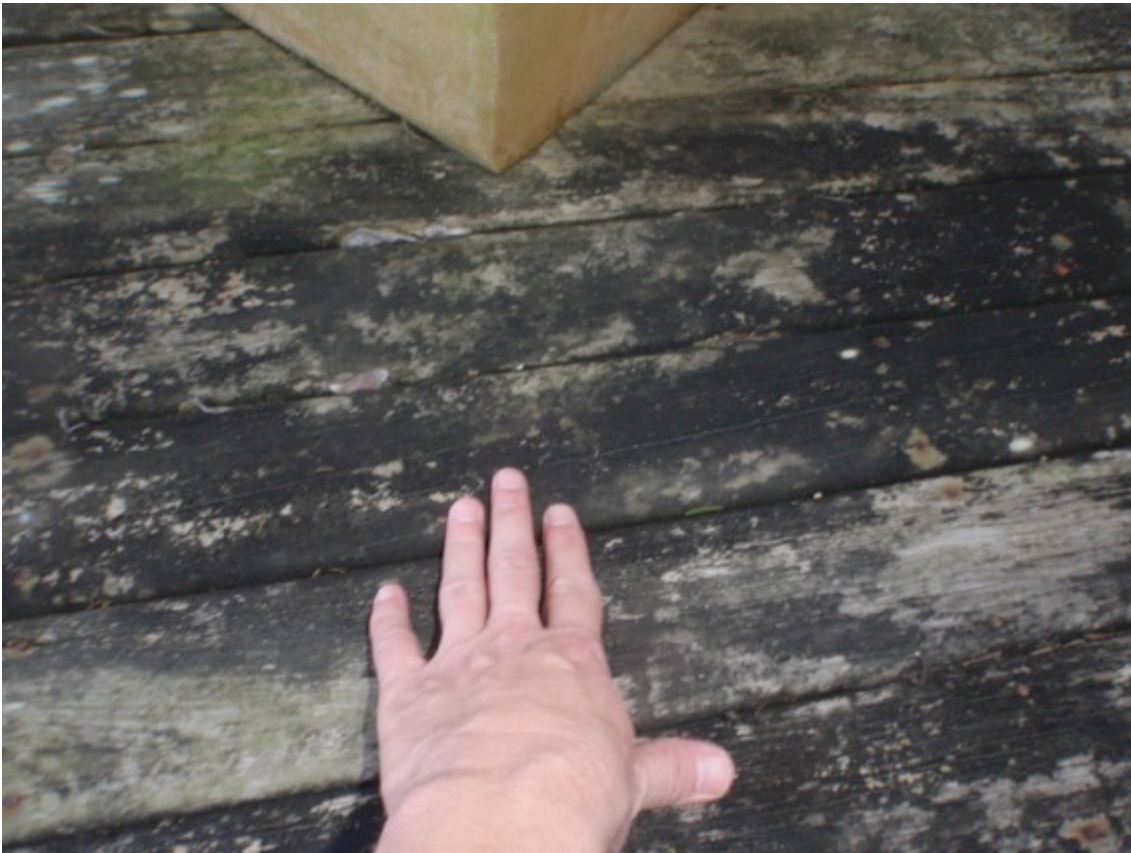
Top floor sound side deck boards are in poor condition and need repairs soon by a qualified contractor

9. **Top floor sound side deck boards are in poor condition and need significant board replacement repairs to ensure safety. \*Boards under planter and additional planter weight need to be evaluated to safely carry load of planter, cover boards can deteriorate quickly is boards cannot be dried out by sun properly.**

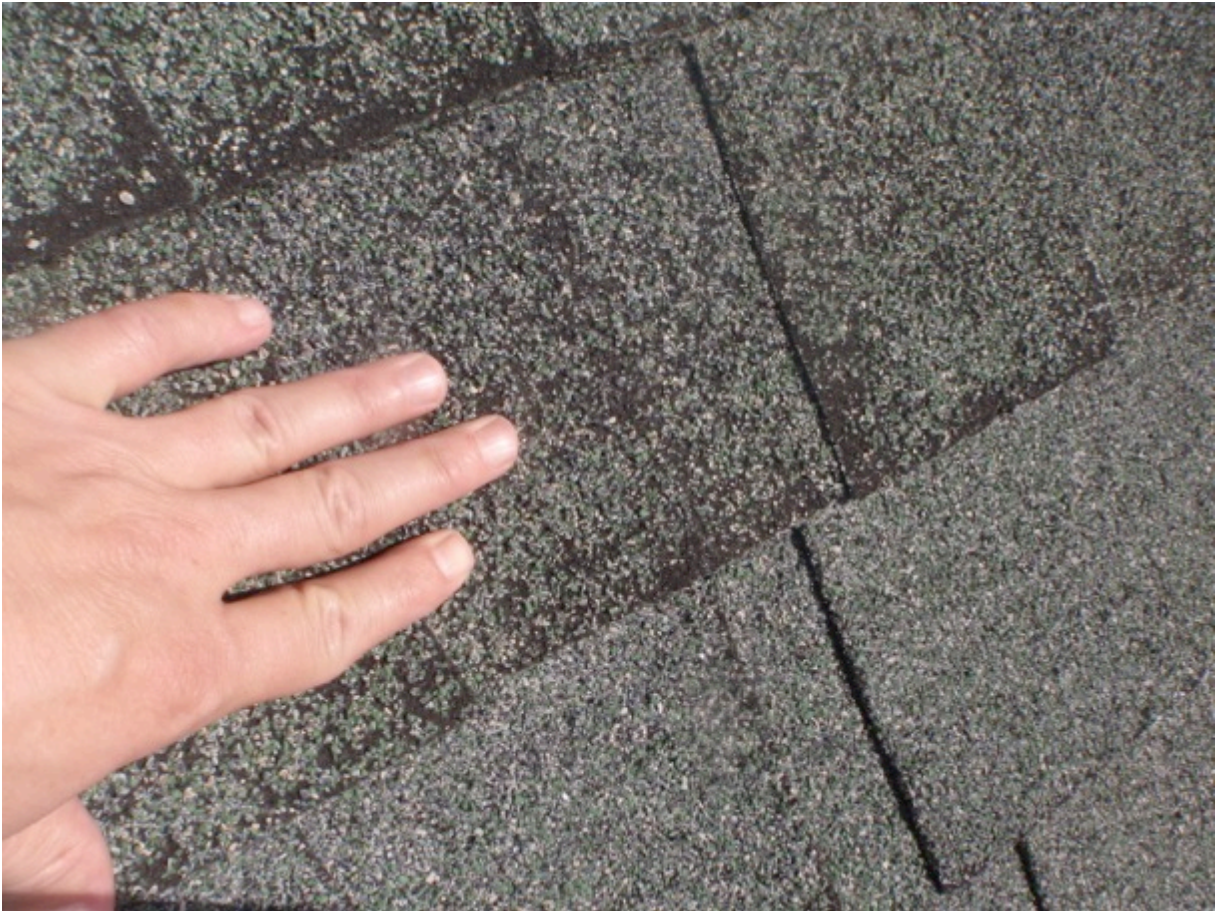
Original shingle tabs were observed on subject home roof, shingles are older and showing signs of weathering and mat granule loss due to age/weather exposure. Some limited life expectancy observed but future shingle updates should be budgeted for in the future

1. Subject home roof shingles are original. Damaged shingle tab problem was observed at top floor gable end shingles over porch. Granule loss to shingle mats were observed and client needs to budget for re shingle of homes roofline in the future. It is recommended a qualified roofer evaluate shingle repairs on roof as well as future life expectancy of shingles and advise client.
2. 2 plumbing vent stacks and boots and roof were observed with multiple past repair attempts to re seal boot on homes roofline. Recommend a qualified roofer repair flashing on two plumbing vent stacks observed on roof.
3. Water stain observed on ceiling sheetrock in kitchen observed, recommend roofer evaluate and advise if a repair is needed at this time.

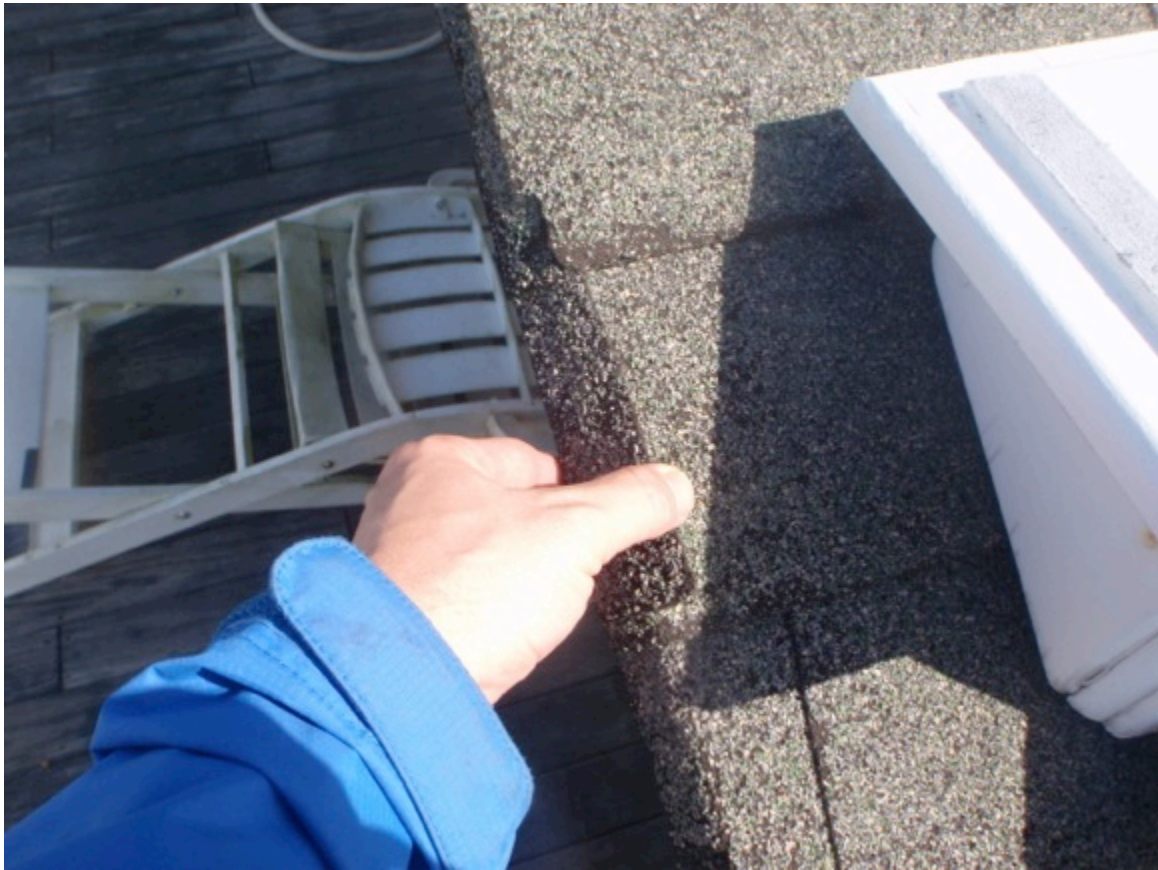
Multiple damaged shingle tabs were observed on roofline by fascia of top floor deck

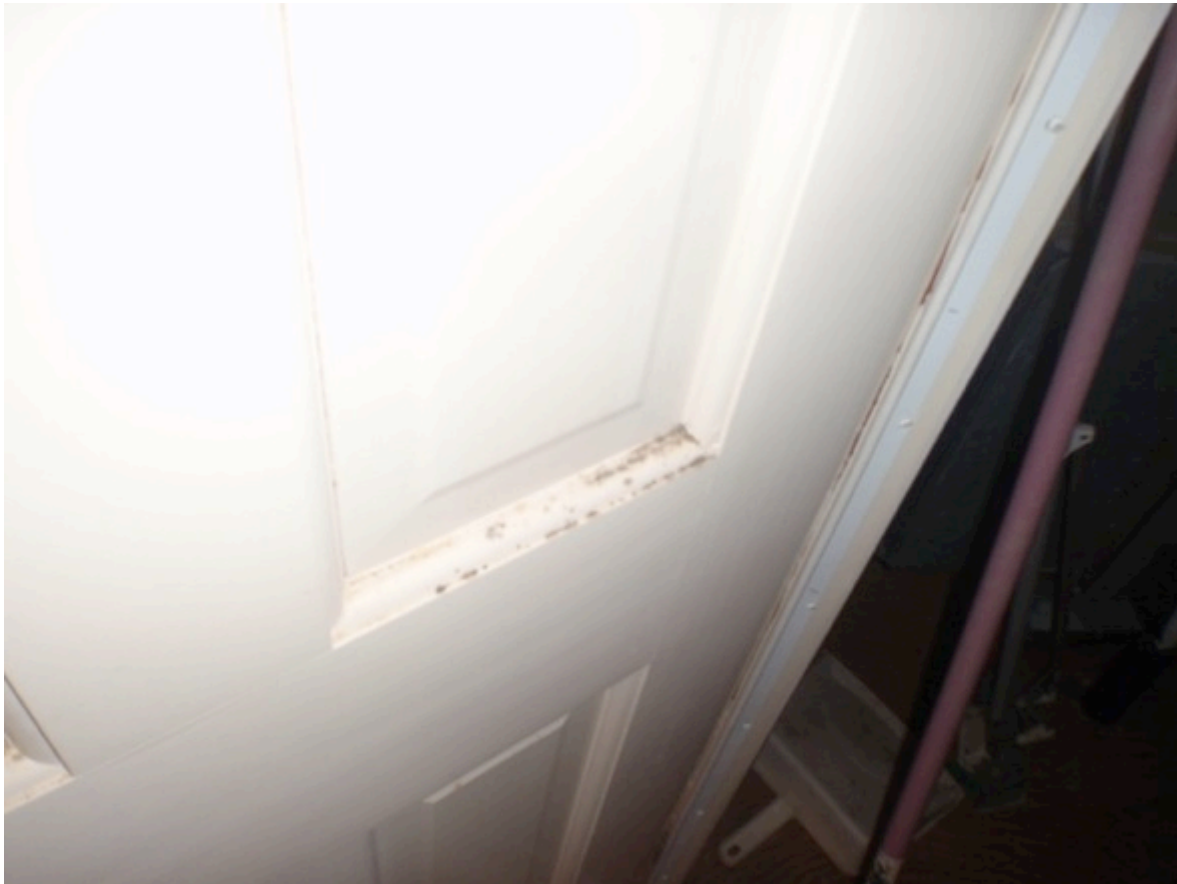
View of mildew/microbial growth exposure was observed on the back of top floor attic access doors

7. **Top floor shower enclosure and door needs adjustment and repair. Door/frame has been knock out of square, recommend contractor repair.**
8. **Presence of microbial growth issues were observed on top floor attic closet doors, (backside of door) 2<sup>nd</sup> floor toilet area and ceiling sheetrock by fan. Recommend further evaluation and cleaning by a qualified professional.**

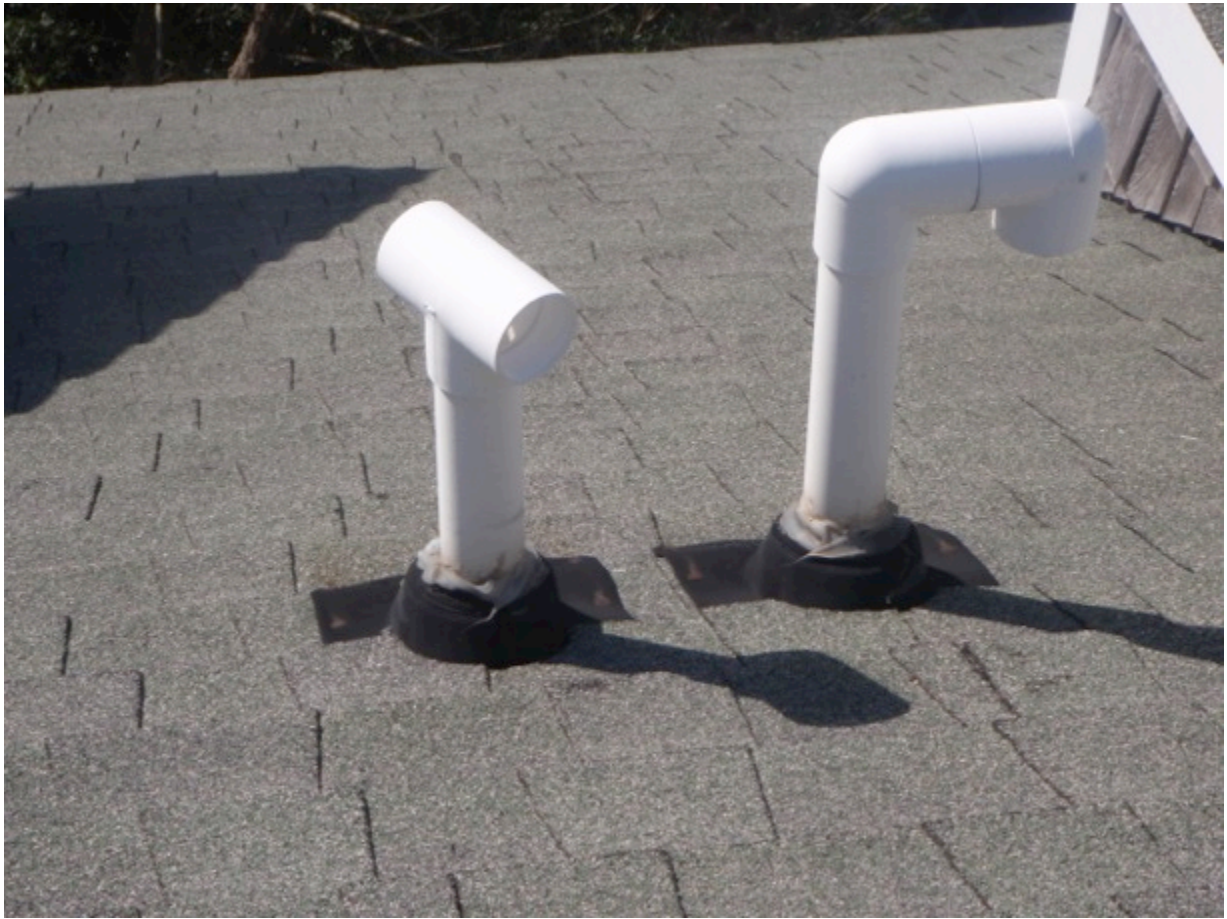
Both plumbing vent stacks on roofline needs flashing/caulk repairs, not non professional patch job attempts (caulking) in above view

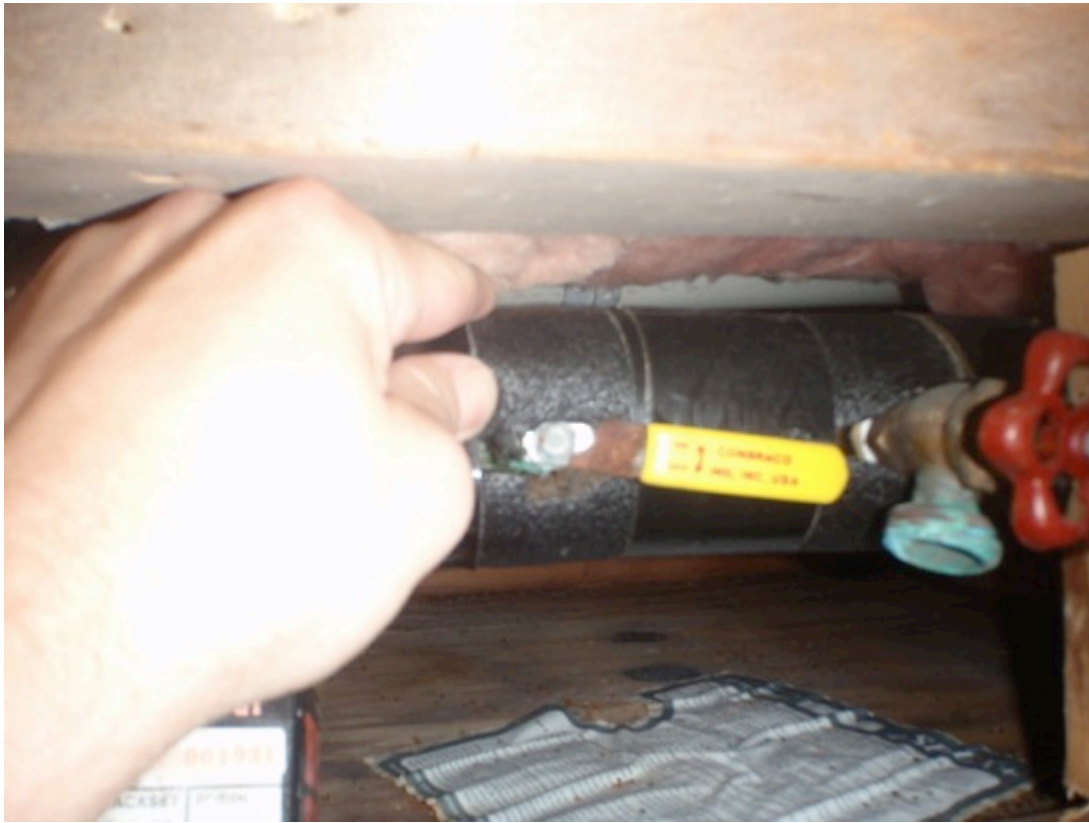
View of leaking/corroded water line turn off handle observed at carport side shed

8. Two heavily corroded and leaking water line turn off handles were observed in 1<sup>st</sup> floor boiler room plumbing and carport closet by side steps. Recommend a qualified plumber repair leaks and replace shut off handles with new.

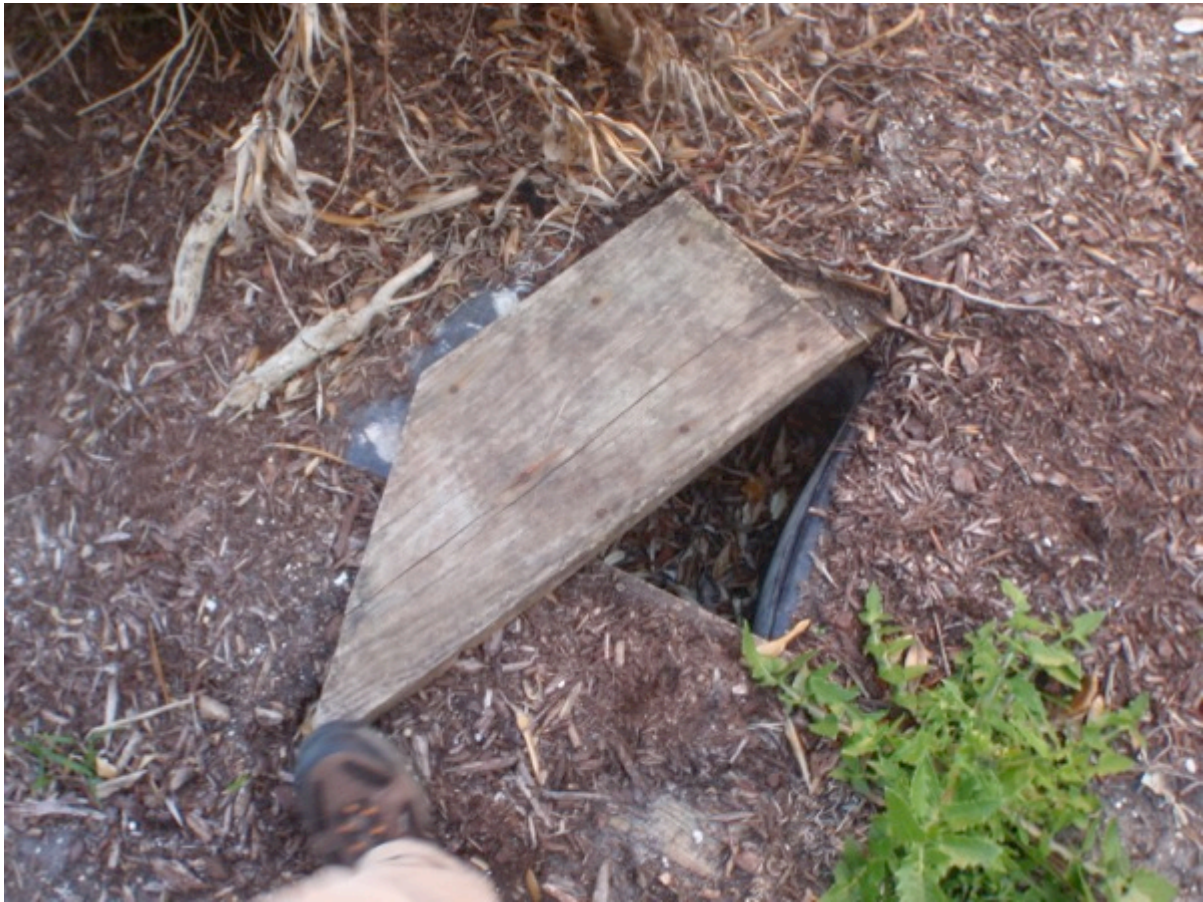
View of broken water meter box observed at right hand side yard water meter turn off meter/handle \*Trip Hazard

- 1. Recommend a licensed pest inspection company perform a termite inspection on subject home and advise client. An active termite bond always needs to be present on subject home moving forward to ensure adequate pest control on structure.**
- 2. Wood to grade contact was observed at front flower bed area of home, recommend pulling flower bed grade back so no wood to grade contact exists at subject location.**
- 3. At right hand side yard of home, water meter cover is broken and is causing a trip hazard, recommend replacing damaged weather meter box.**

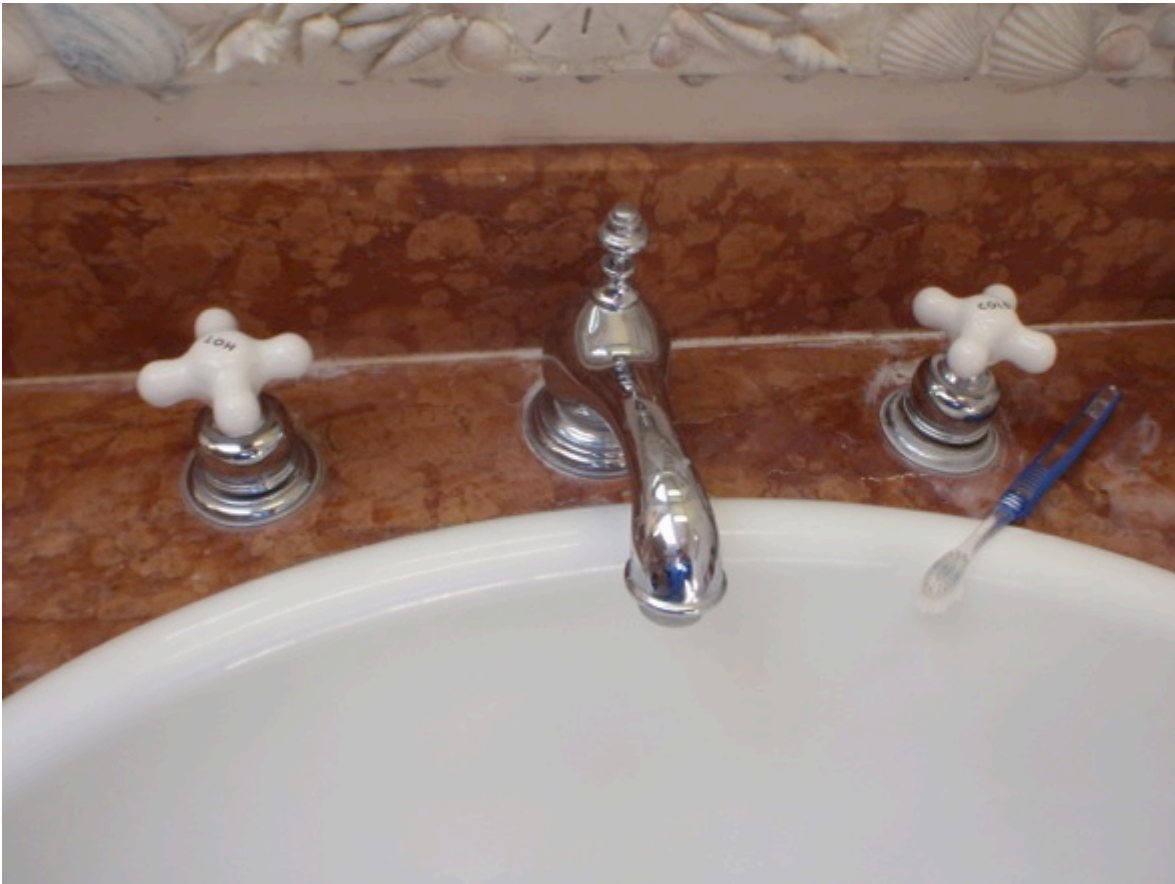
A good majority of the homes original plumbing operation handles leak at fixture gaskets when operated, see summary page comments
