# WILMINGTON INSPECTION GROUP

Name: John Sample  
Address: \_\_\_\_\_  
\_\_\_\_\_  
E-Mail: [john@inspectilm.com](mailto:john@inspectilm.com)  
Inspection Ordered by: Client  
Property Address: 123 Wilmington Lane  
Age: 2015  
Square Footage: 1234+  
Date Performed: 1234+  
Reason for the Inspection: Prepurchase

## I. Foundation, Basement and Structure

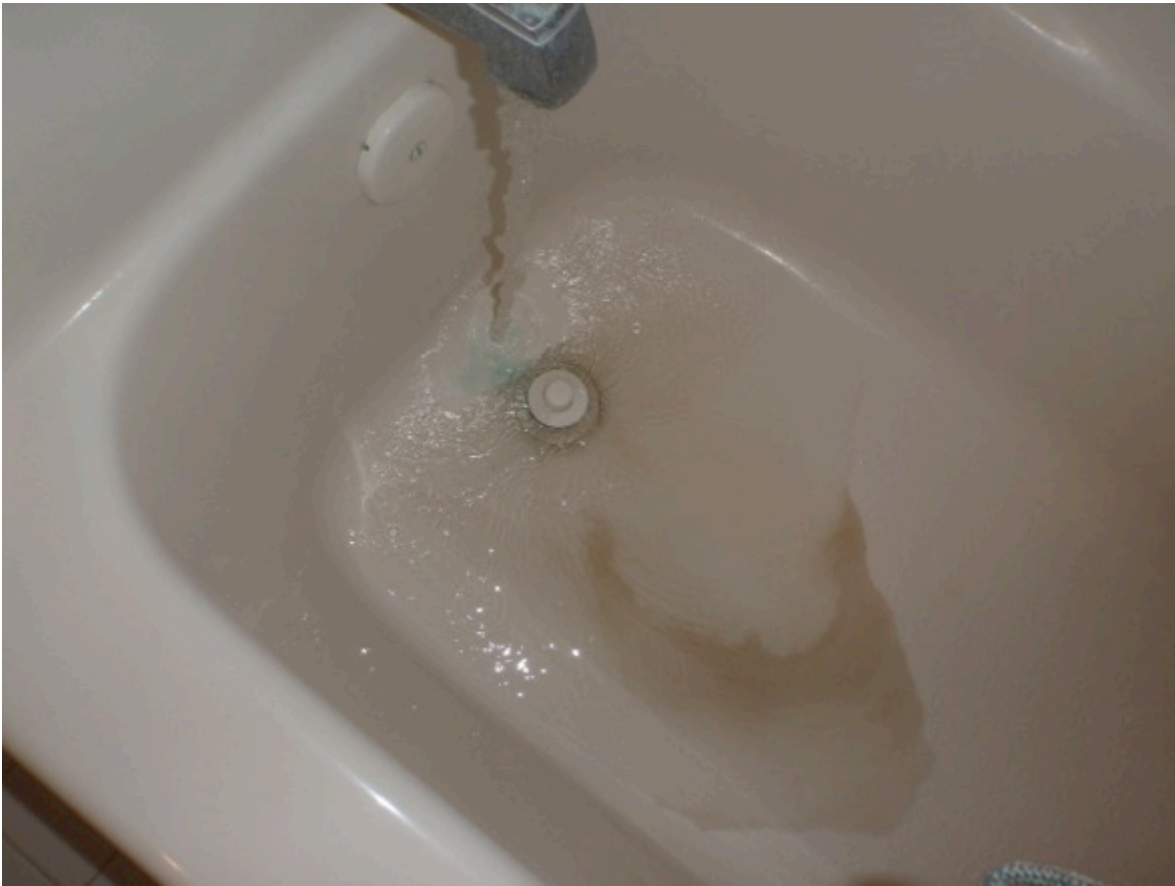
View of dirty fixture water was emitting from homes plumbing (copper vs. lack of use)

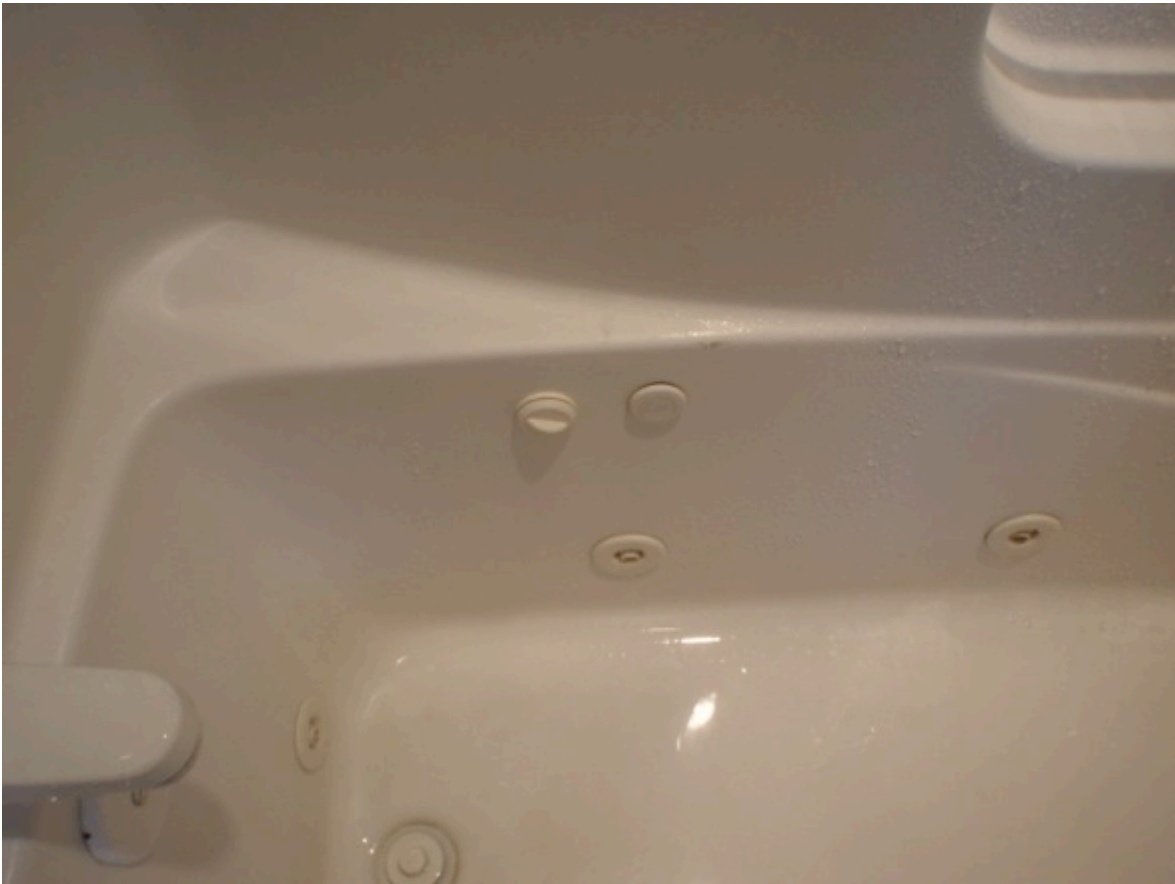
2<sup>nd</sup> floor Whirlpool jets kept tripping breaker in carport breaker panel box at time of inspection

4. 2<sup>nd</sup> floor Jacuzzi motor GFI breaker kept tripping during jet operation at exterior panel in carport, recommend a licensed electrician replace bad GFI breaker at homes breaker panel for 2<sup>nd</sup> floor.

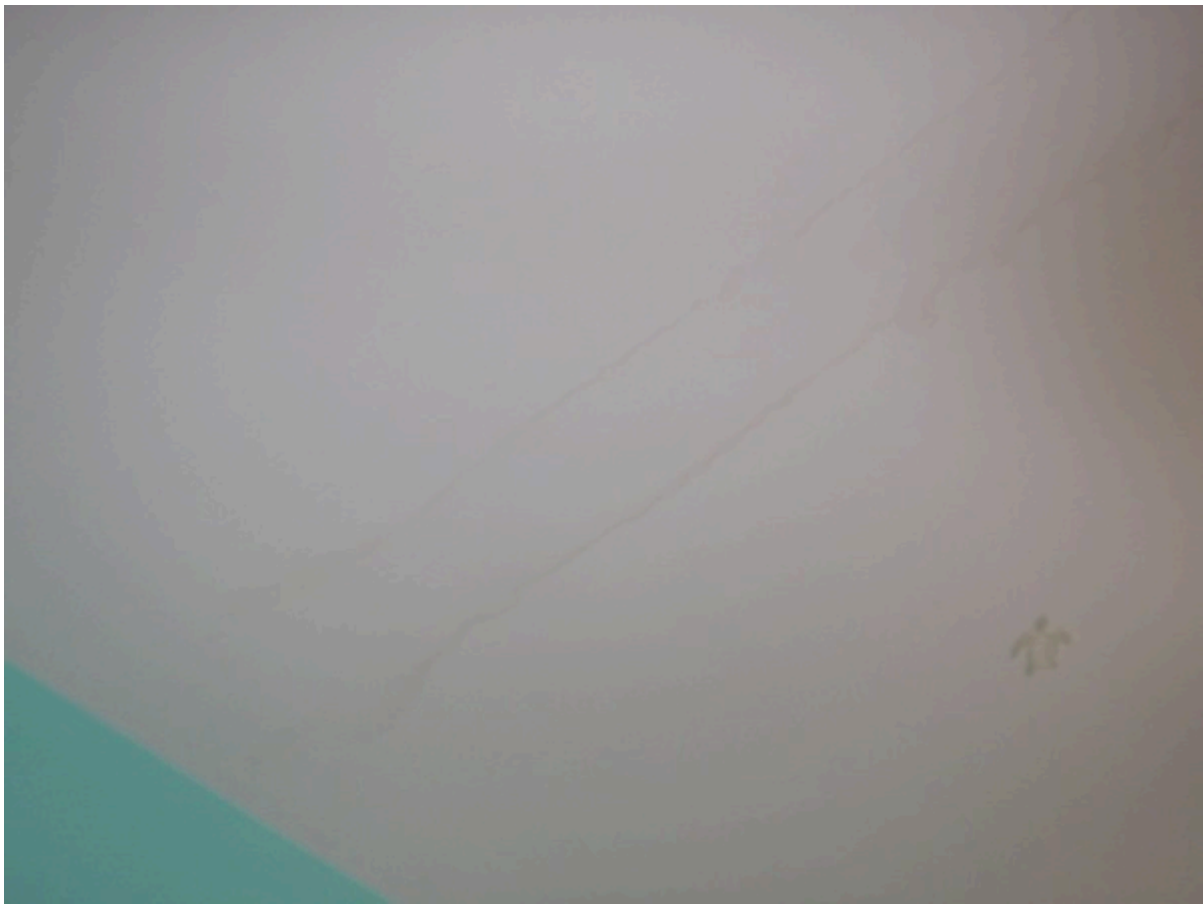
View of plumbing leak observed at 2<sup>nd</sup> floor front guest bedroom ceiling sheetrock coming from 3<sup>rd</sup> floor plumbing fixture

1. Plumbing leak observed at 2<sup>nd</sup> floor front bedroom ceiling from 3<sup>rd</sup> floor plumbing area. Note big water stain on ceiling sheetrock on 2<sup>nd</sup> floor front guest bedroom ceiling. Recommend a qualified plumber evaluate and repair.

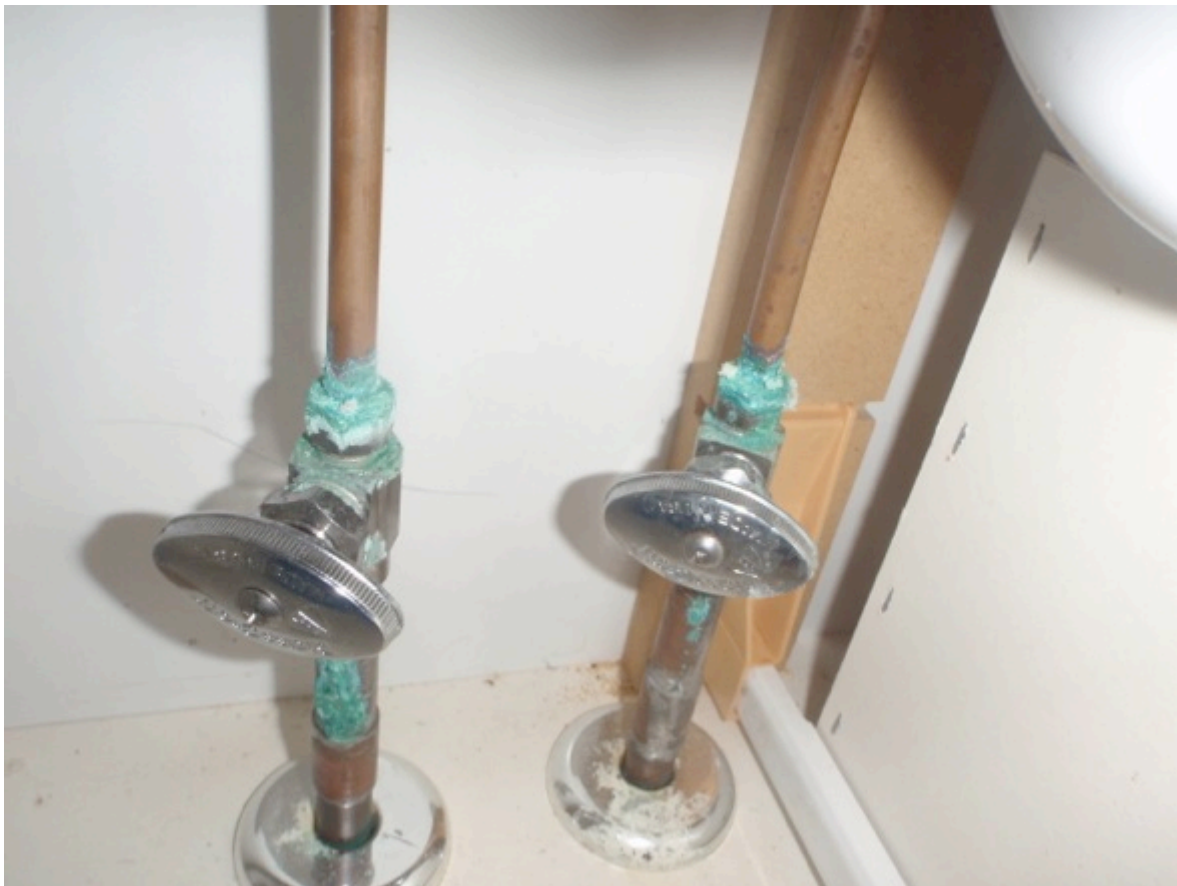
Majority of homes fixture to handle water line connections or showing signs of corrosion from heavy use and salt air exposure (Common at beach) repair as needed basis or change out with new plastic by plumber

9. Majority of homes fixture turn off/on handles under sinks and toilets were observed with corrosion issues with turn off handles extension piping that carries water from handle to fixture. Recommend plumber update to plastic on all fixture handle extension piping at interior fixtures at subject home. \*Common at the beach.

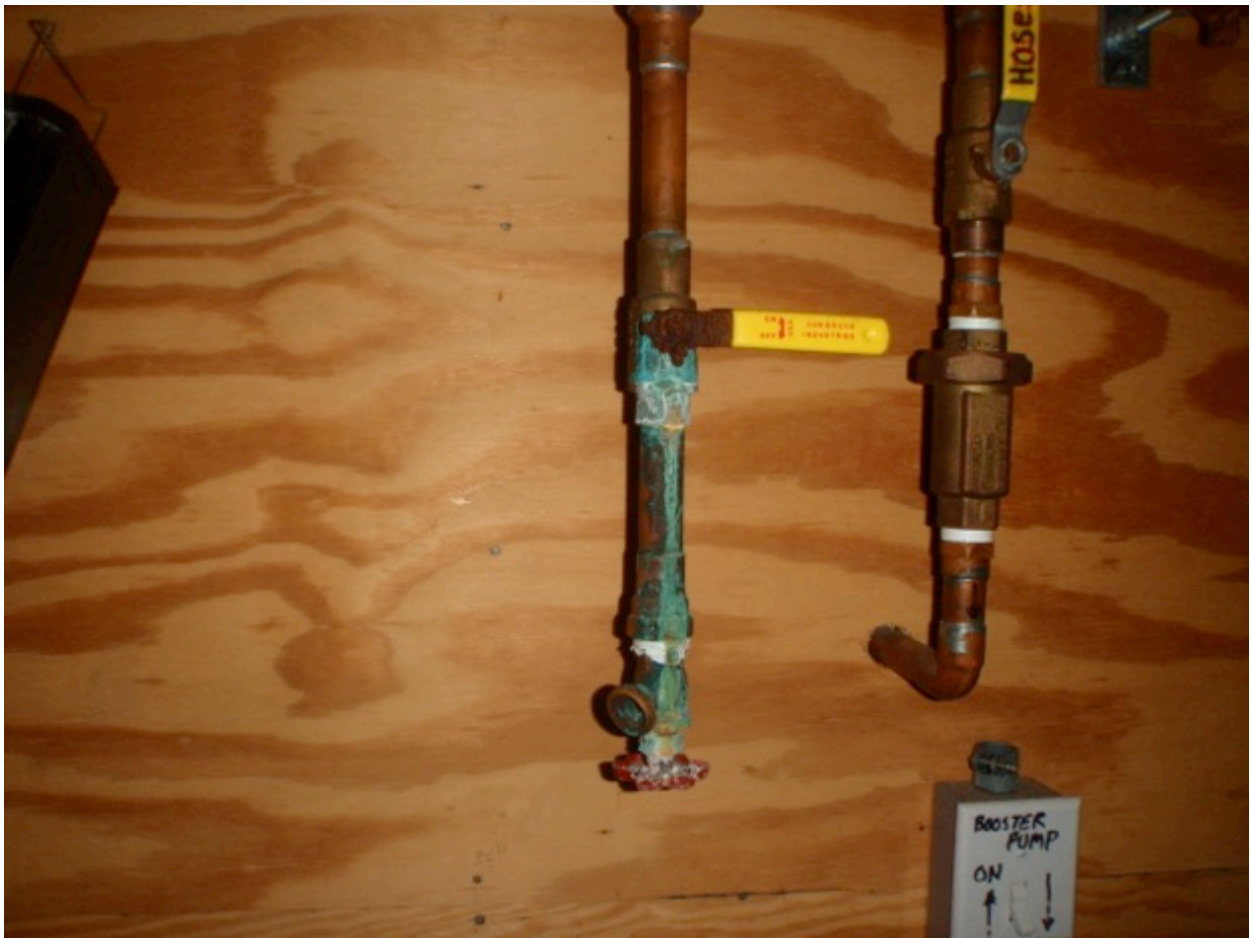
View of leaking handle and corroded handle observed at boiler room plumbing fixture at time of inspection

8. Two heavily corroded and leaking water line turn off handles were observed in 1<sup>st</sup> floor boiler room plumbing and carport closet by side steps. Recommend a qualified plumber repair leaks and replace shut off handles with new.

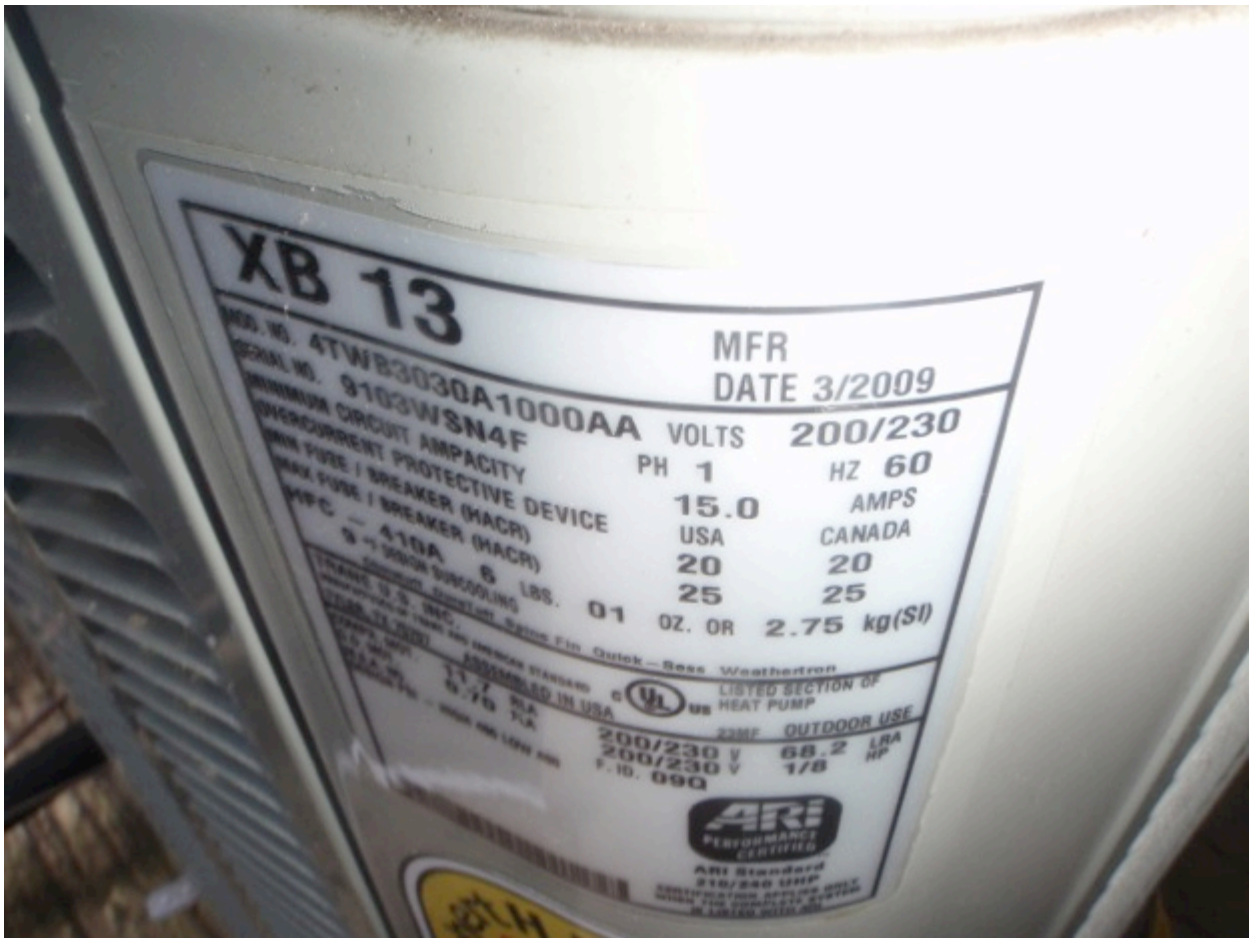
4 out of five HVAC heat pumps were updated in the 2000's, one is original

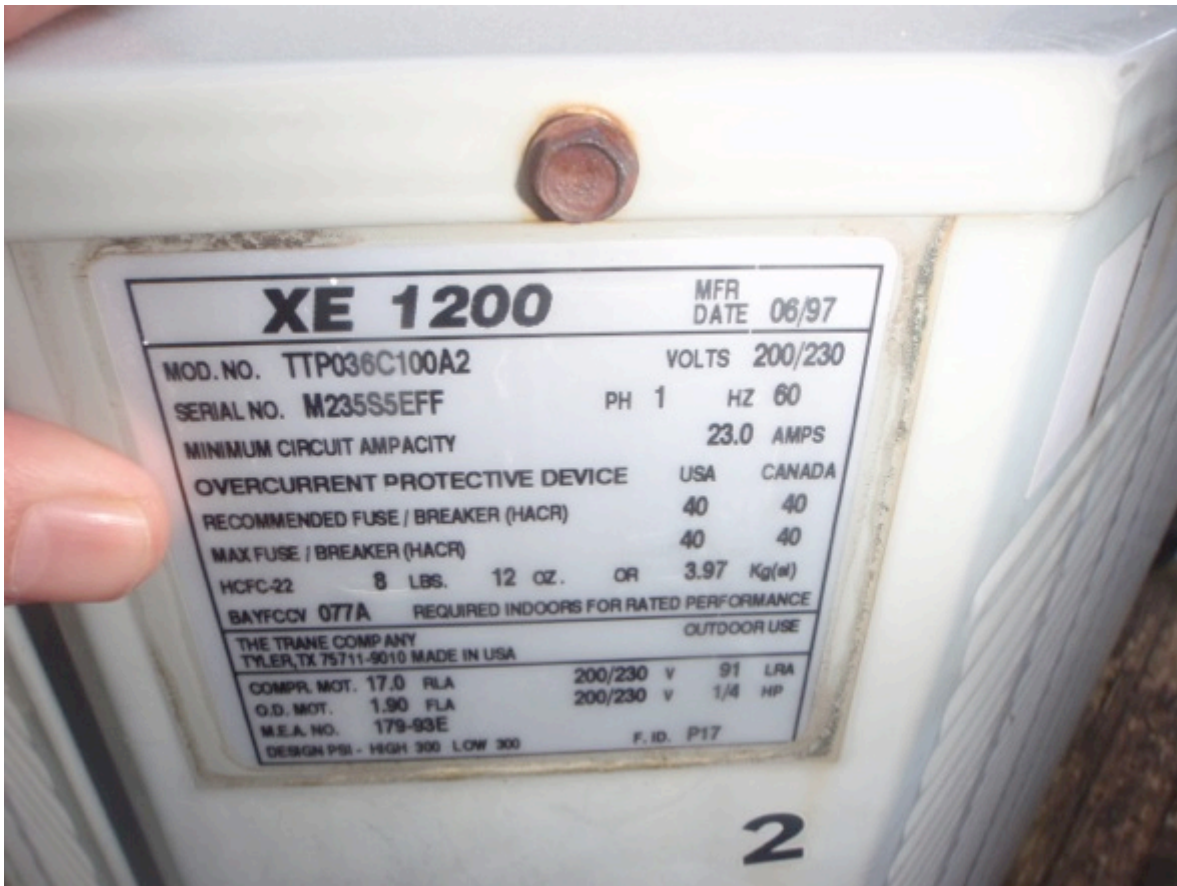
View of original HVAC unit observed for subject home, only one out of four systems has not been updated

1. All laundry room dryer vents/piping need to be cleaned, lint debris build up observed, (potential hazard). Exterior dryer vent cap was also observed missing at right hand side yard of home. Recommend repair/cleaning.
2. HVAC units at subject home consist of 5 split level electric heat pumps. Four units were updated in the 2000's and one unit is original to 1997. All units need to have spring service and tune up evaluation performed on equipment so units are working at peak performance for summer season wear and tear. All condensation drain lines need to be blown out and all filters changed also. HVAC professional needs to evaluate original unit and advise client on future life expectancy of dated component.

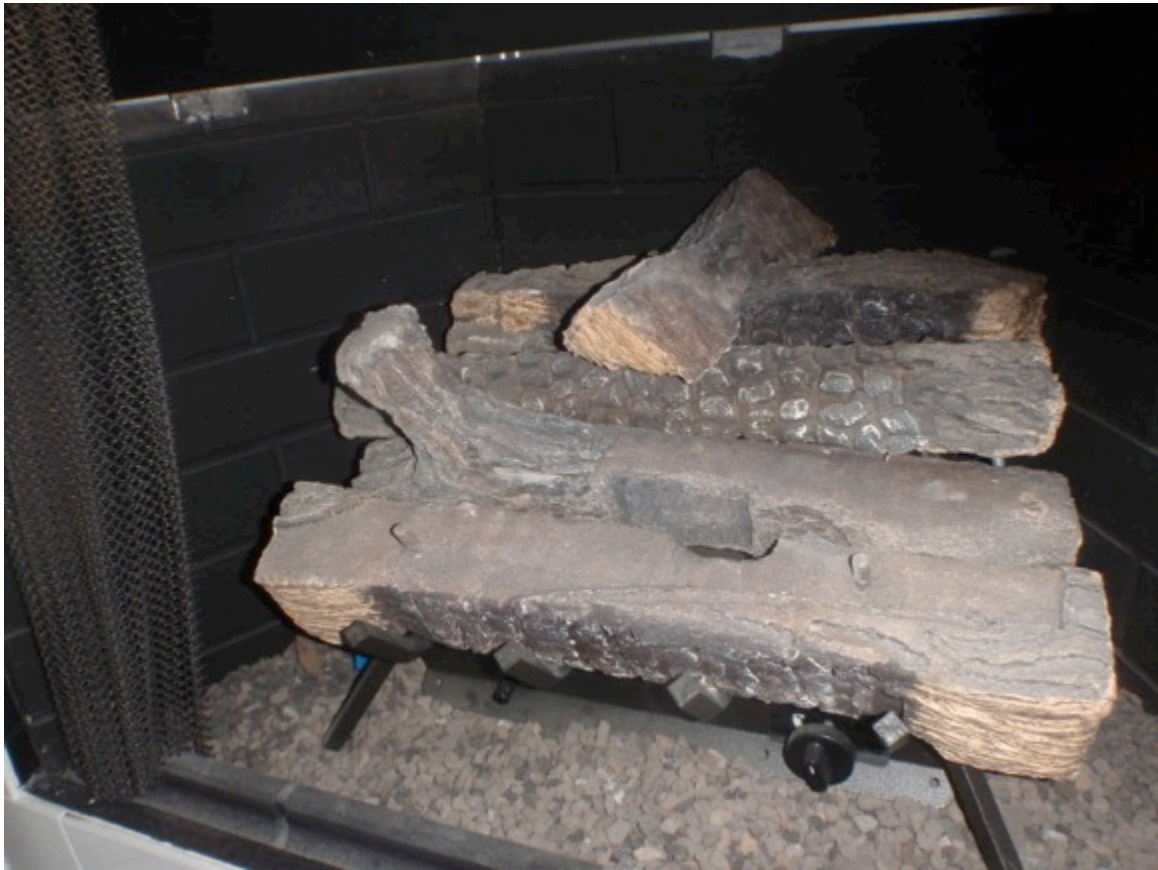
Vent less gas logs sets observed for subject home, client should have log set up serviced yearly

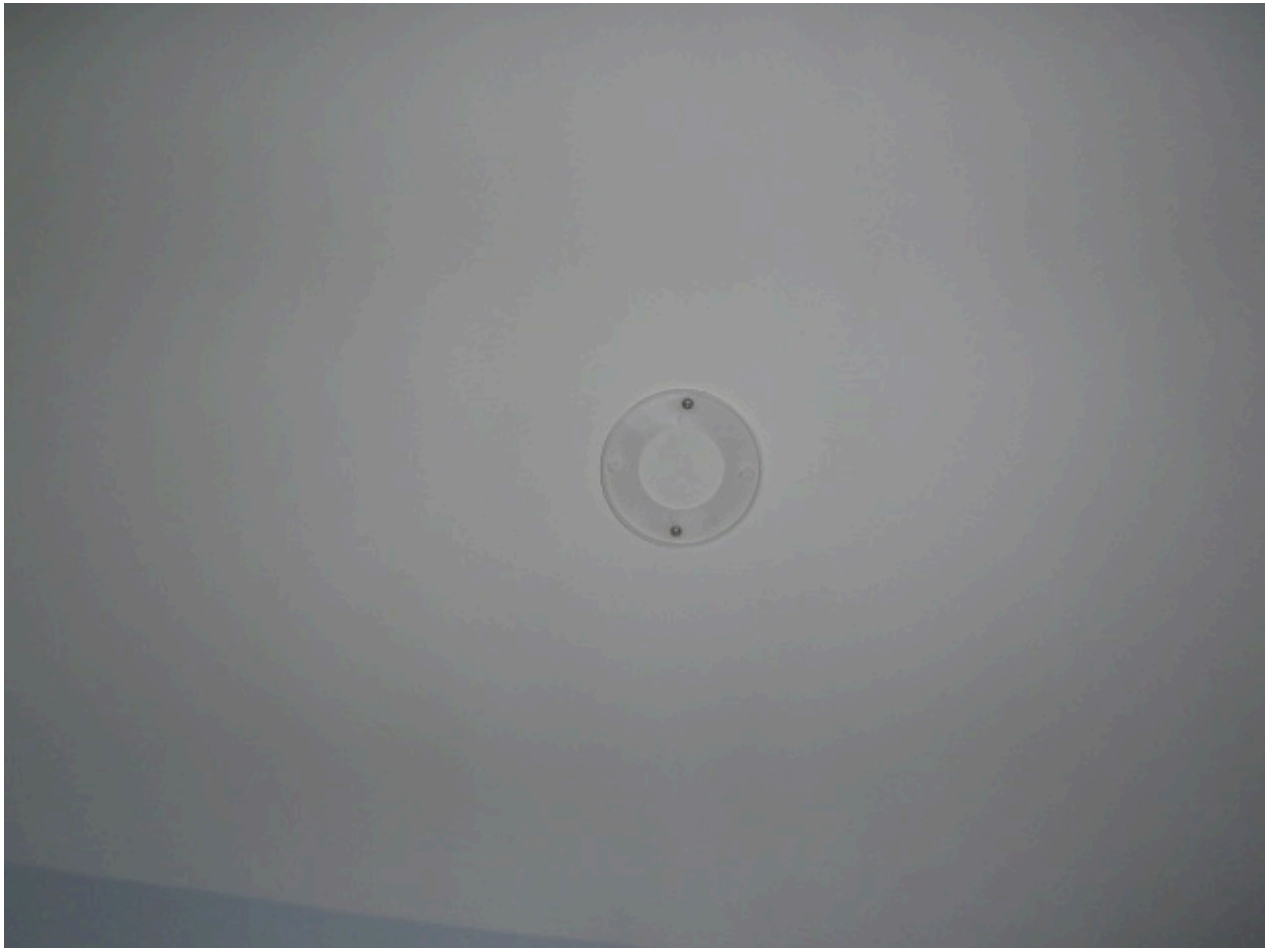
View of missing smoke detector observed on 2<sup>nd</sup> level of home, see summary page comments concerning homes smoke detectors

1. **Missing and several non operable smoke detectors were observed at subject home. Smoke detectors are also original and out of manufactories warranty. It is recommended a licensed electrician evaluate and update to new all subject home smoke detectors with hardwired battery back up new models for safety.**

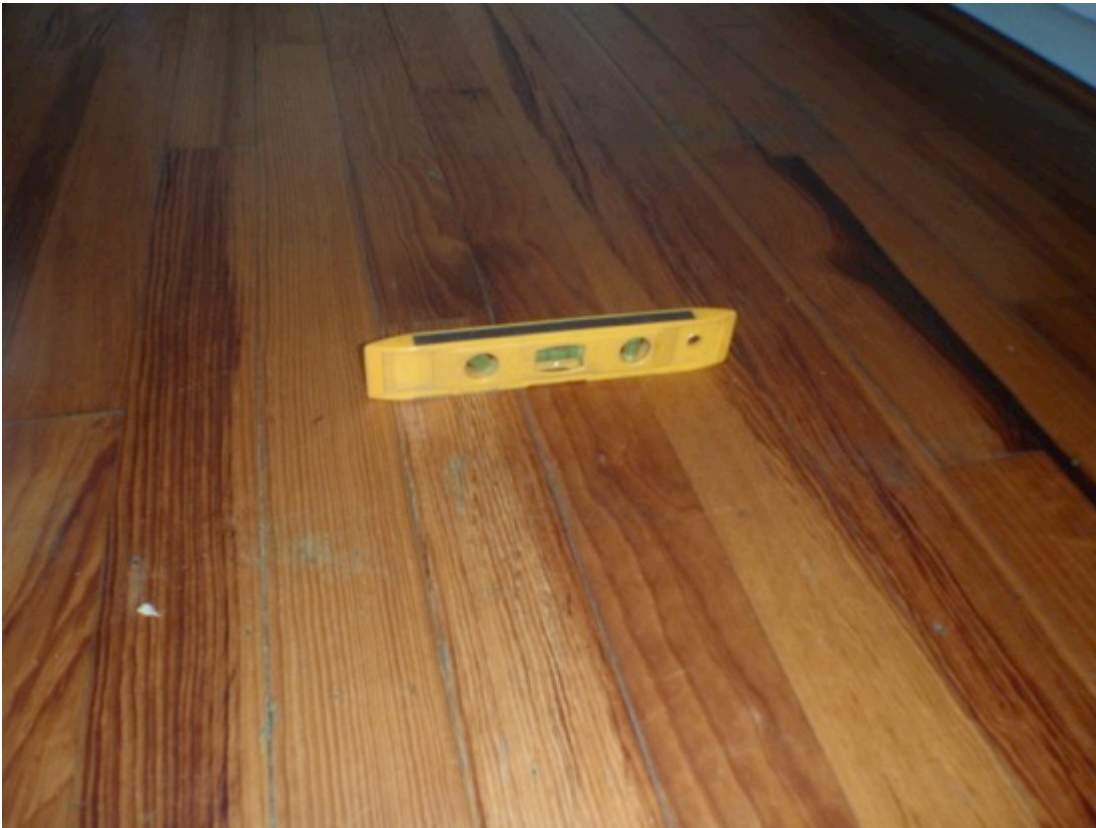
Top unit floor spans supports run a long ways length wise, some bounce/play observed in flooring, some settlement appears to have occurred over the years

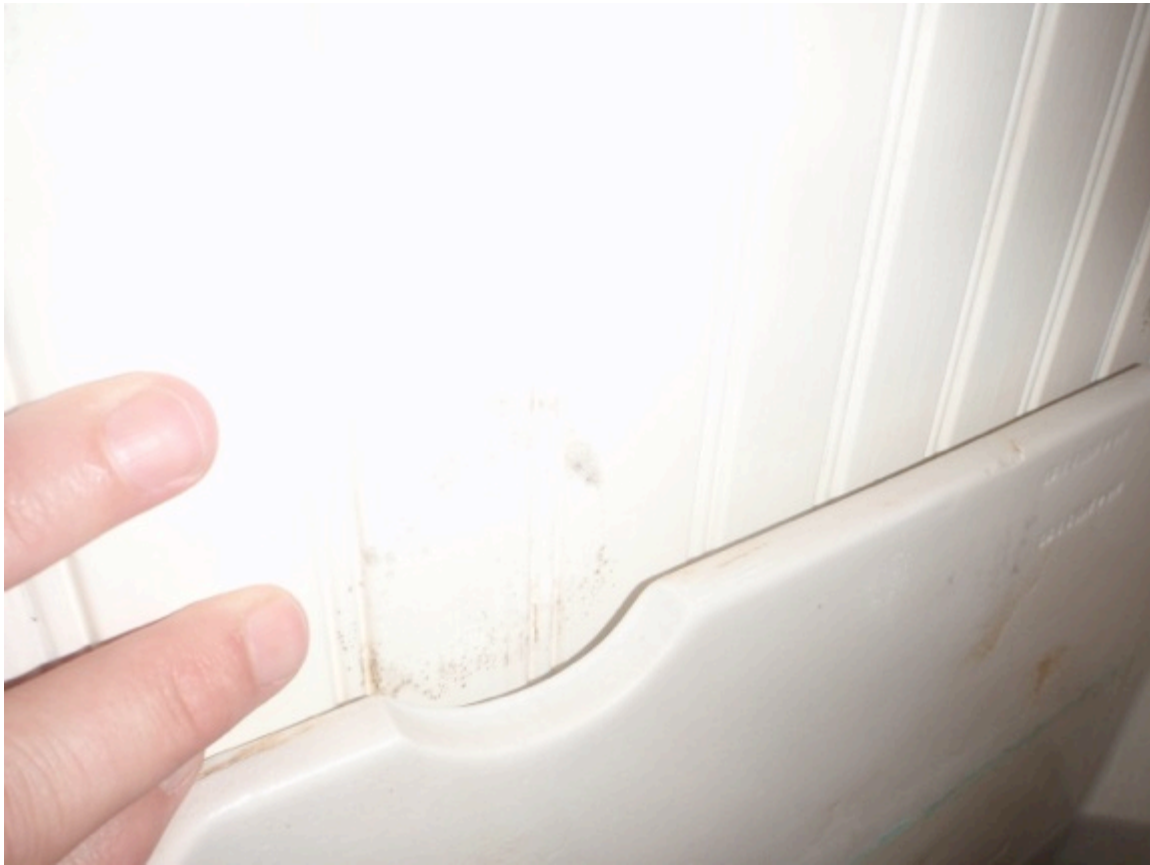
View of microbial growth presence observed on 2<sup>nd</sup> floor hall bathroom behind toilet and ceiling sheetrock by fan above toilet

7. **Top floor shower enclosure and door needs adjustment and repair. Door/frame has been knock out of square, recommend contractor repair.**
8. **Presence of microbial growth issues were observed on top floor attic closet doors, (backside of door) 2<sup>nd</sup> floor toilet area and ceiling sheetrock by fan. Recommend further evaluation and cleaning by a qualified professional.**

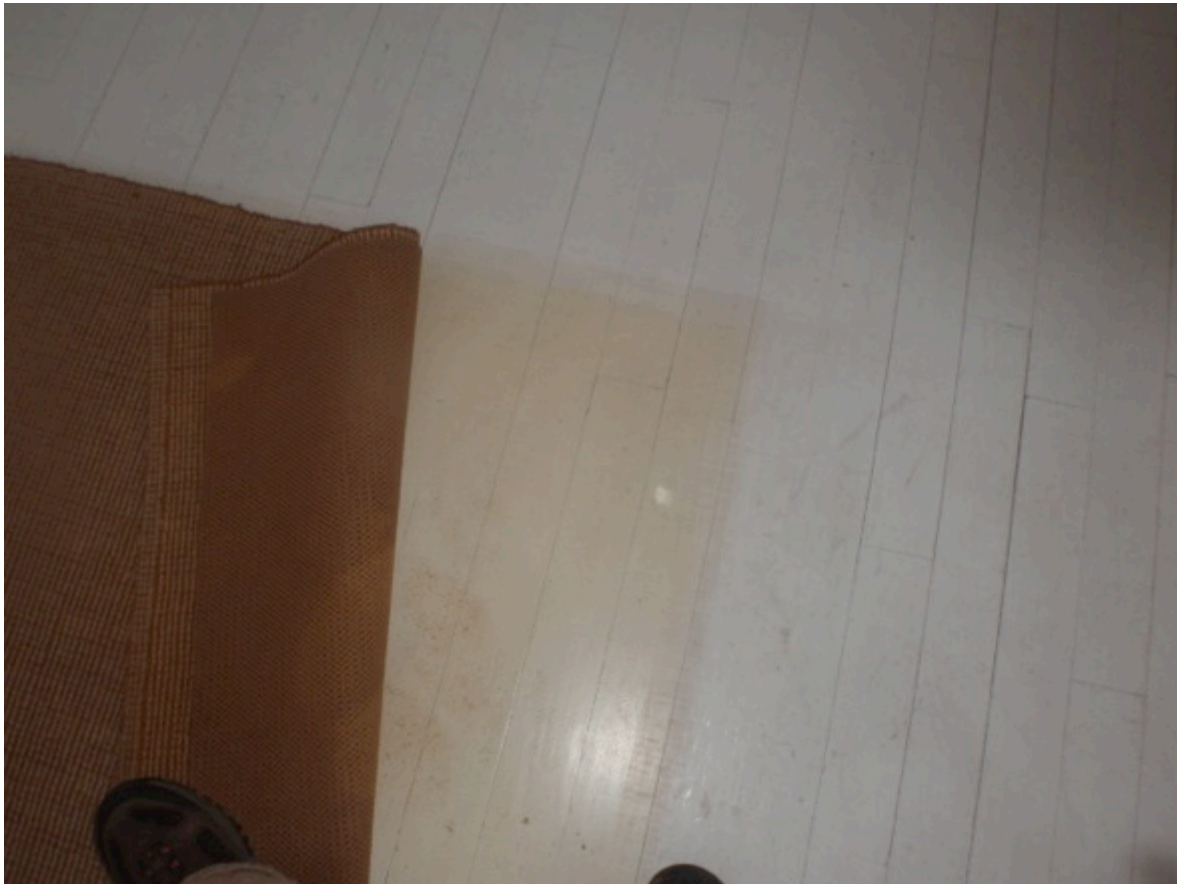
2<sup>nd</sup> level flooring needs to be repainted and some moisture damaged boards observed in front of laundry room

\*Two different colors due to area rug coverage

4. **Flooring on 2<sup>nd</sup> level is different colors due to long term area rug exposure and it appears a past leak may have occurred and warped several flooring boards in front of laundry room. Recommend a qualifed contractor evaluate and repair/refinish.**

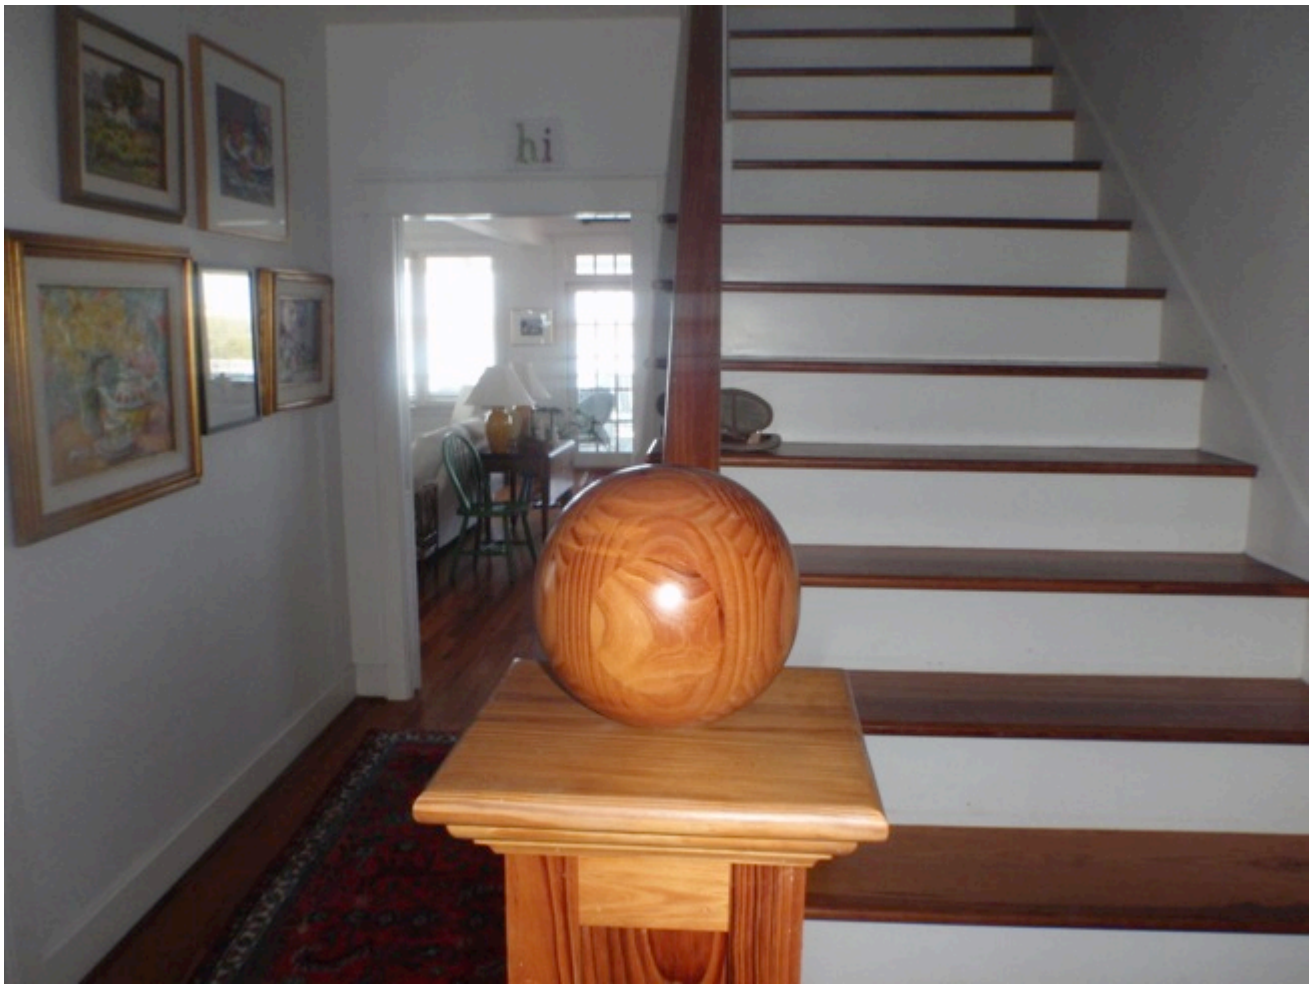
Top floor stair railing is loose and need securing repair for safety

5. **3<sup>rd</sup> to 4<sup>th</sup> floor interior stair handrail is loose and needs securing repair for safety.**
6. **Pocket door lock broken at 2<sup>nd</sup> floor bathroom tub, recommend repair.**

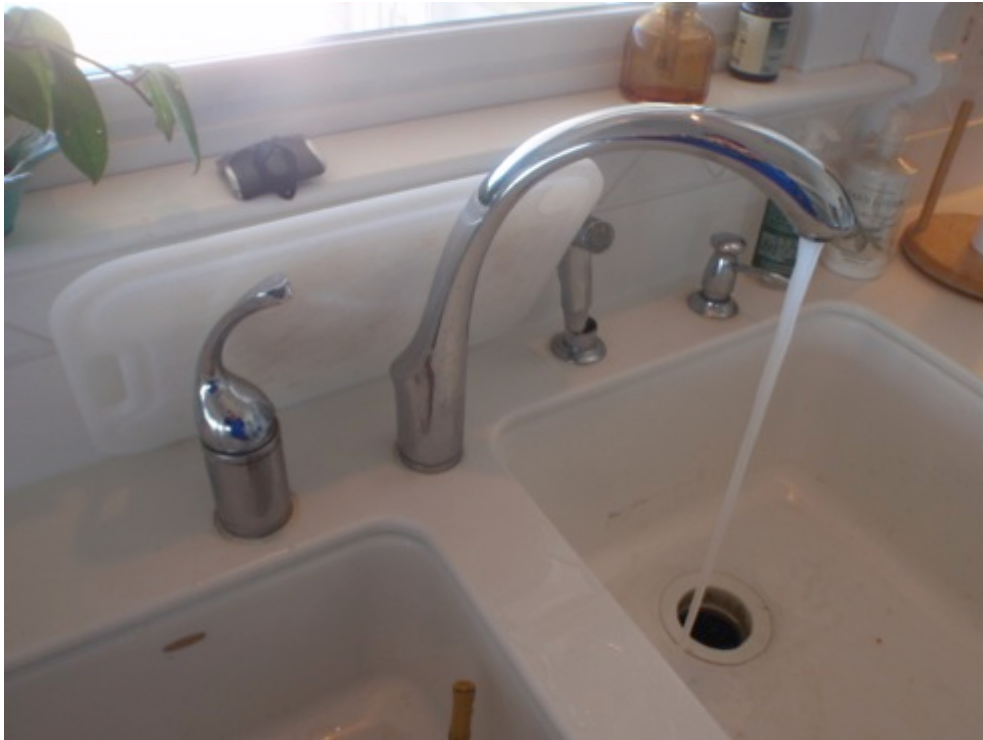
Both kitchen sink faucet handles leak at fixture gaskets during operation

2. All exterior shower handles leak at fixture gaskets when operated. Recommend a qualified plumber replace all exterior shower fixture handles.
3. Both kitchen sink faucet handles (2<sup>nd</sup> and 3<sup>rd</sup> floor) need repair. Handles leak as gaskets during faucet operation, recommend plumber repair.
